# Construction Foundation Report

## Mud Mountain Dam Seepage Control Cutoff Wall

White River, Washington

August 1991

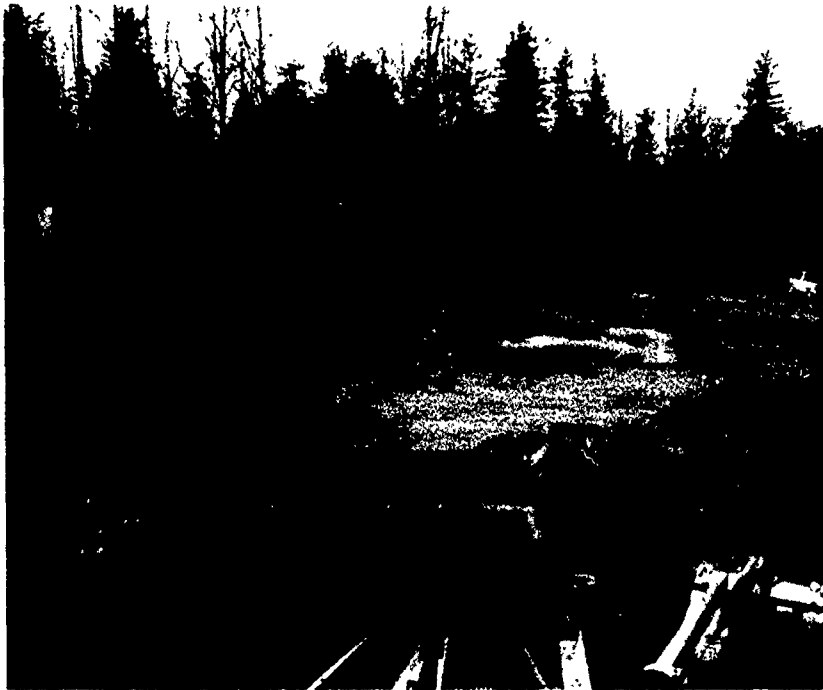
Winterization. 10-inch diameter steel pipe arrangement for the coarse aggregate stockpile.

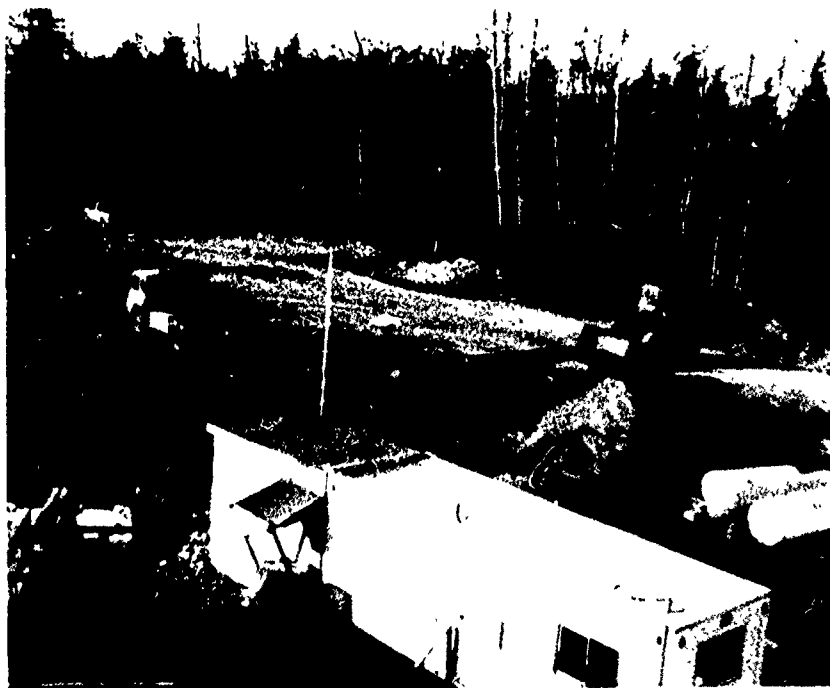
Winterization. Steel pipe arranged for the sand stockpile. The building is the contractor quality control laboratory.

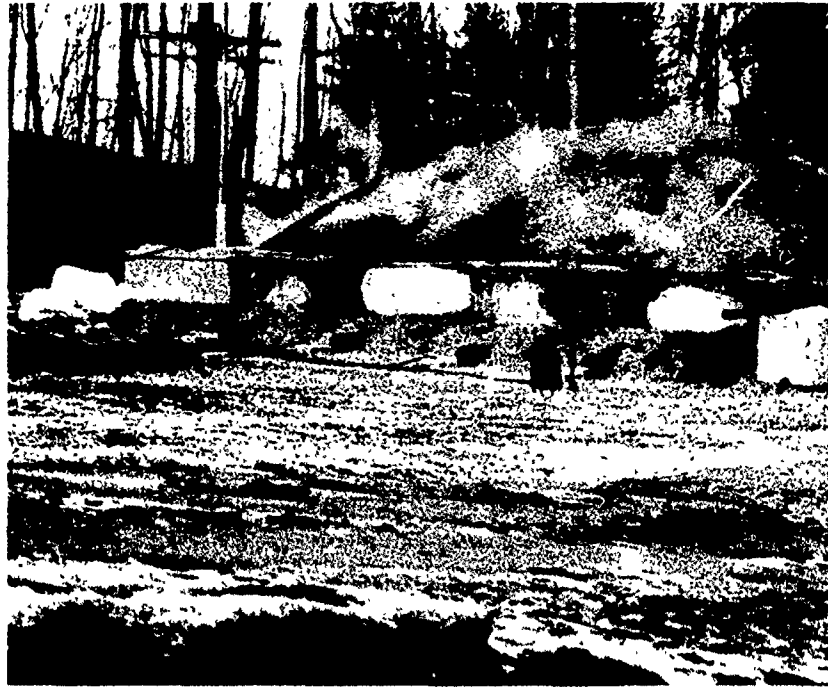
Winterization. Propane heaters in use on the coarse aggregate stockpile.

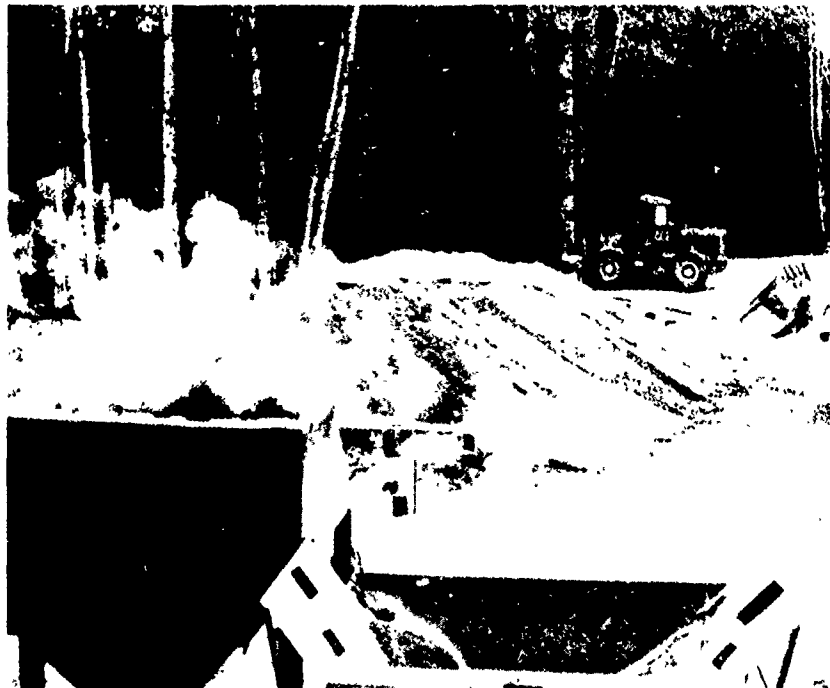
Winterization. Coarse aggregate stockpile showing tarpulin cover.
