FLOOD CONTROL CHANNELS RESEARCH PROGRAM

CONTRACT REPORT HL-92-1

## IDENTIFICATION OF PIPING AND SAPPING EROSION OF STREAMBANKS

D. J. Hagerty

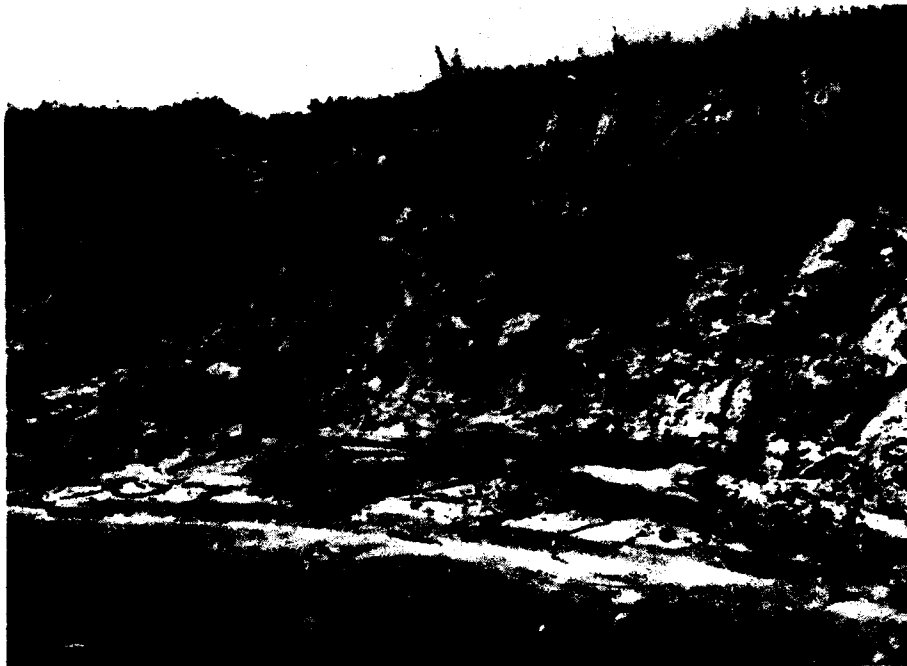
d. Piping/sapping with collapse of undercut layer

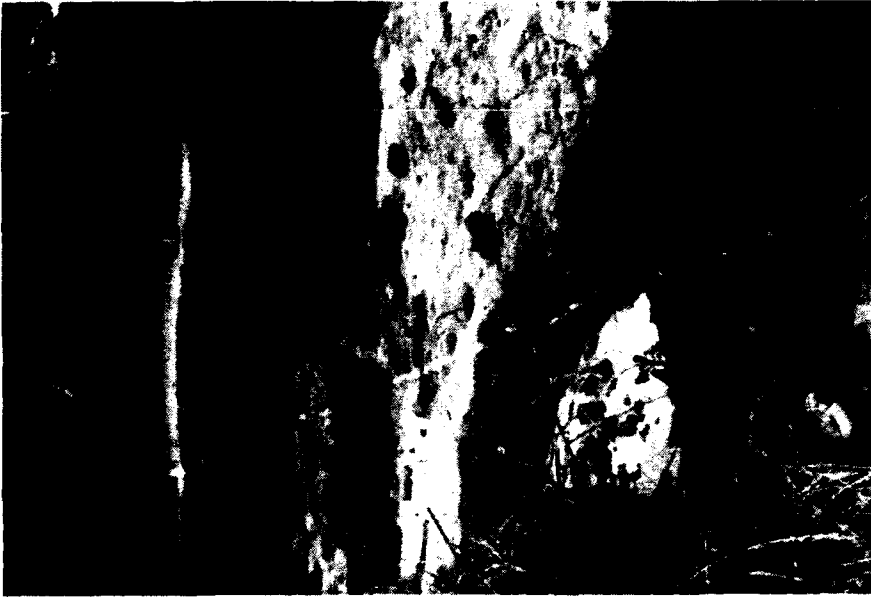
f. Piping cavities in recent sediments over stiff cohesive soil layer

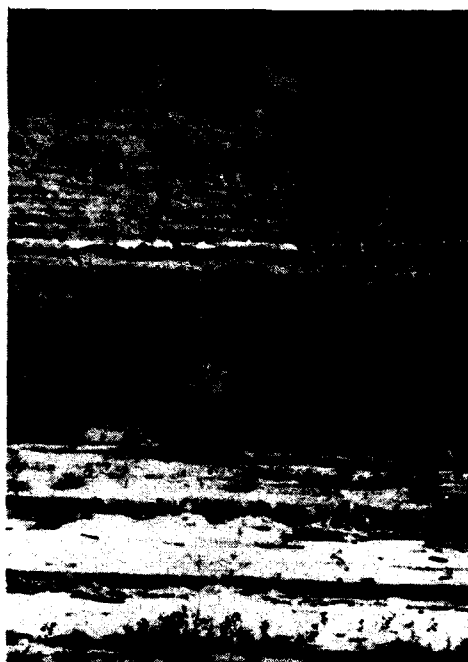
i. Piping cavities in bank  
shown in Figure 1e (Note  
sapping scarps in fore-  
ground)

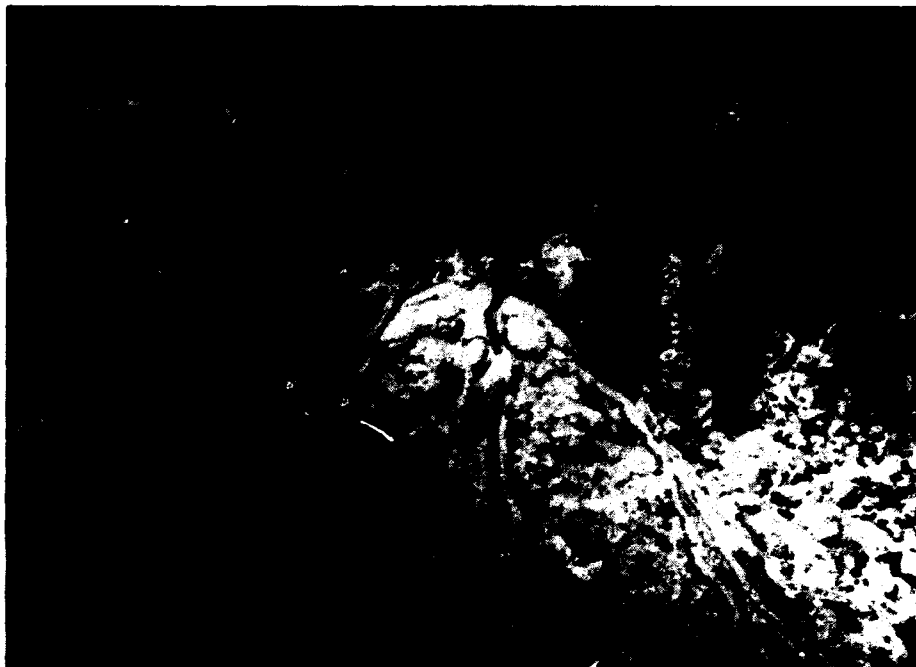
a. Fine sand and silt, carried by flow out of upper-bank piping zone and deposited in front of lower sapping cavities

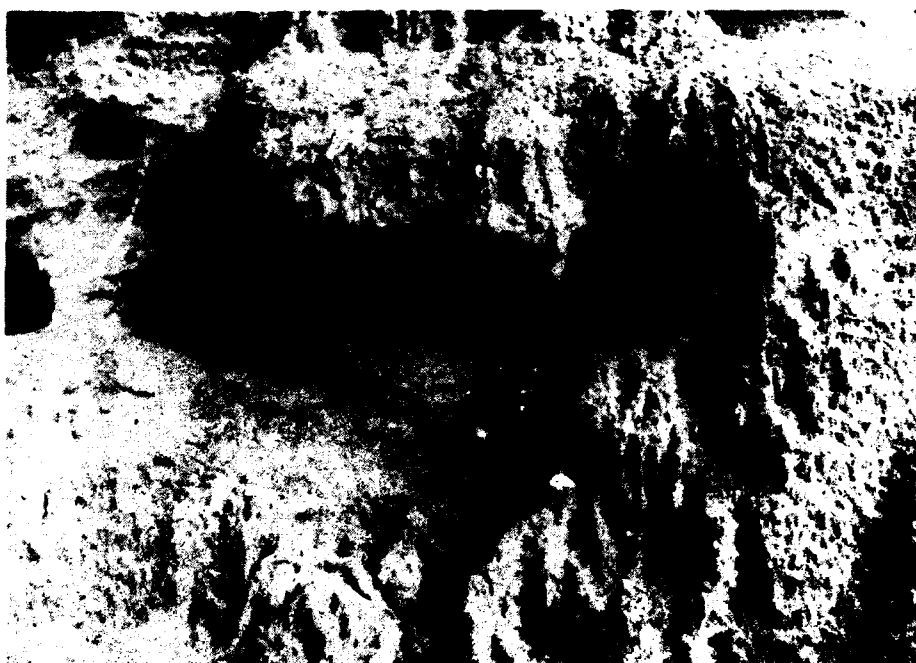
b. Fine sand and silt flow film over and in front of piping cavities

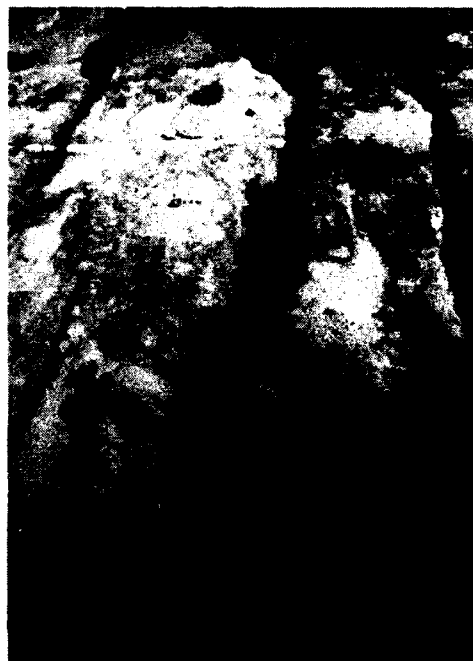
e. Blind gullies below piping  
zone in bank
