**T-38 FORWARD WINDSHIELD DEVELOPMENT AND PERFORMANCE  
DEMONSTRATION REPORT**

J. W. MYERS  
PPG INDUSTRIES, INC.  
AIRCRAFT PRODUCTS  
P.O. BOX 2200  
HUNTSVILLE, AL 35804

March 12, 1992

Final Report for period June 1982 to September 1989

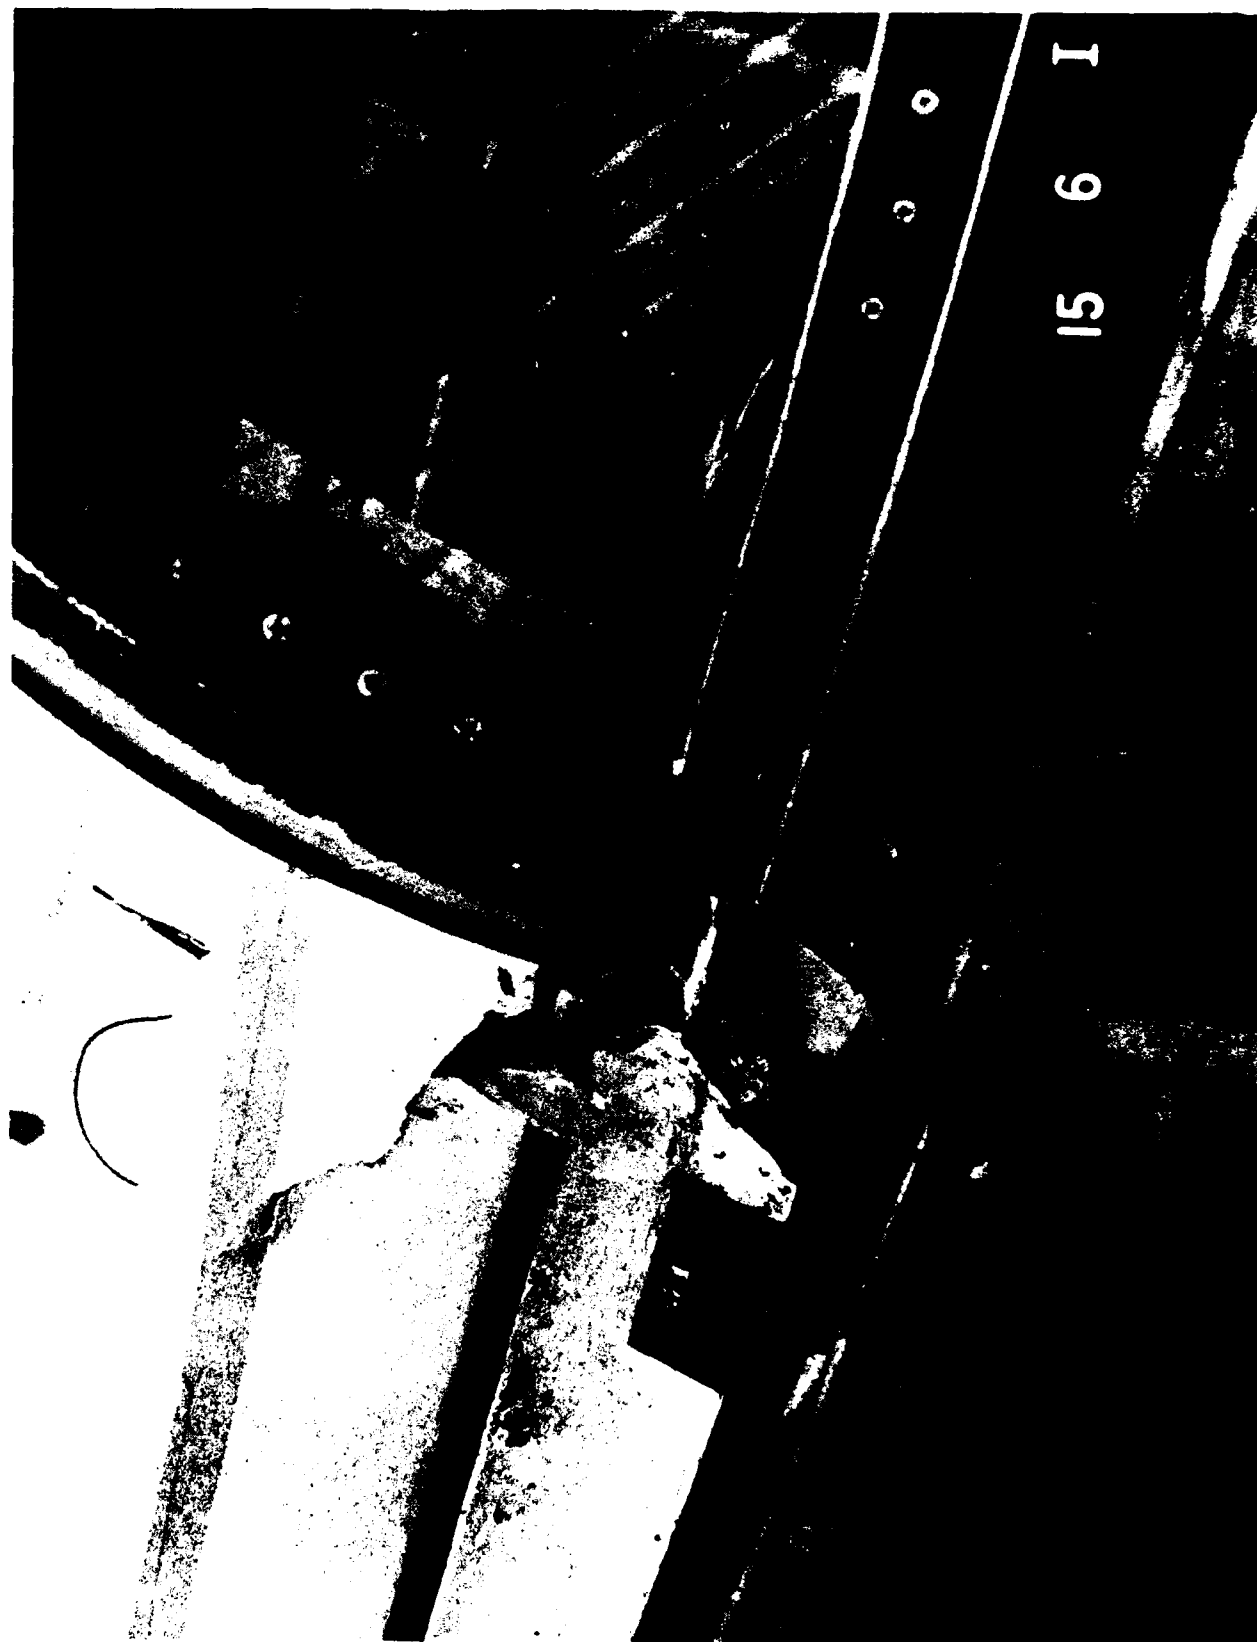
Photograph #9. Post-Test Lower W/S &  
Canopy Frame Shot #156

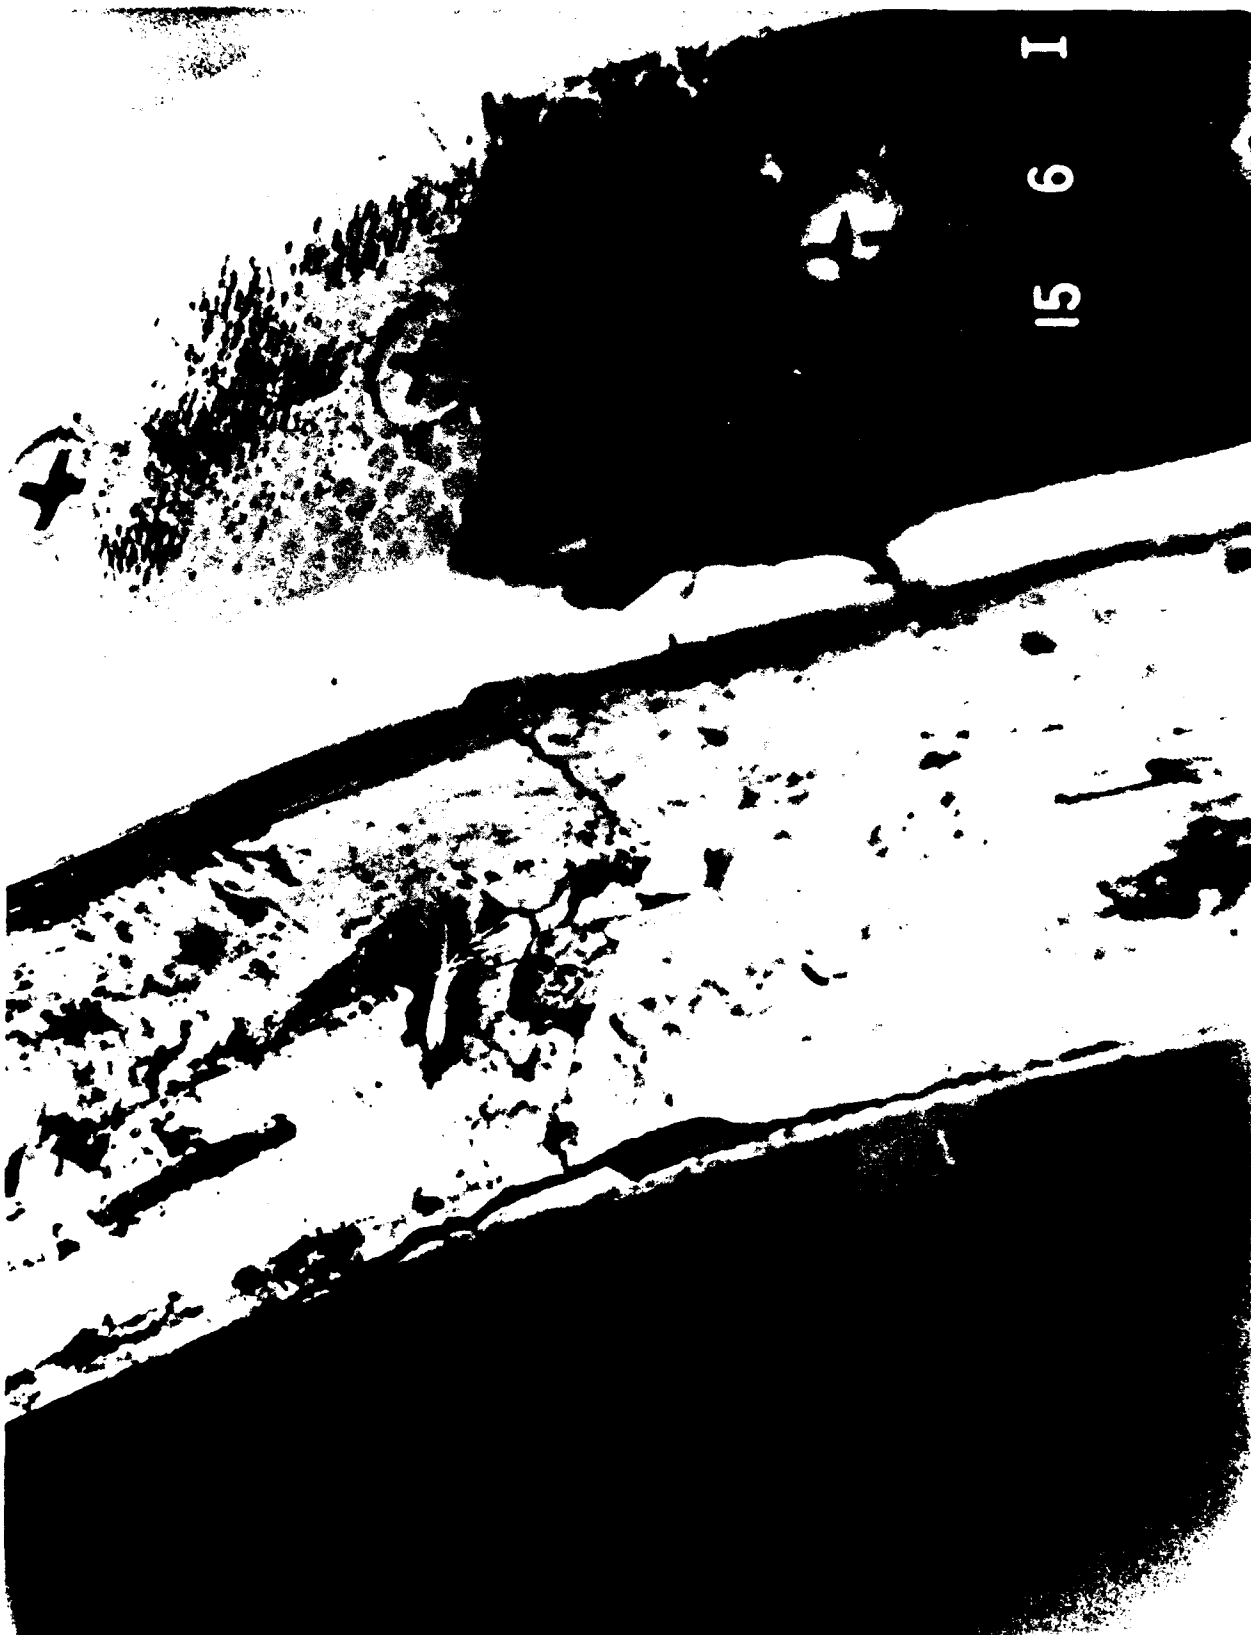
Photograph #11. 1/4 Point Close Up View  
Shot #156

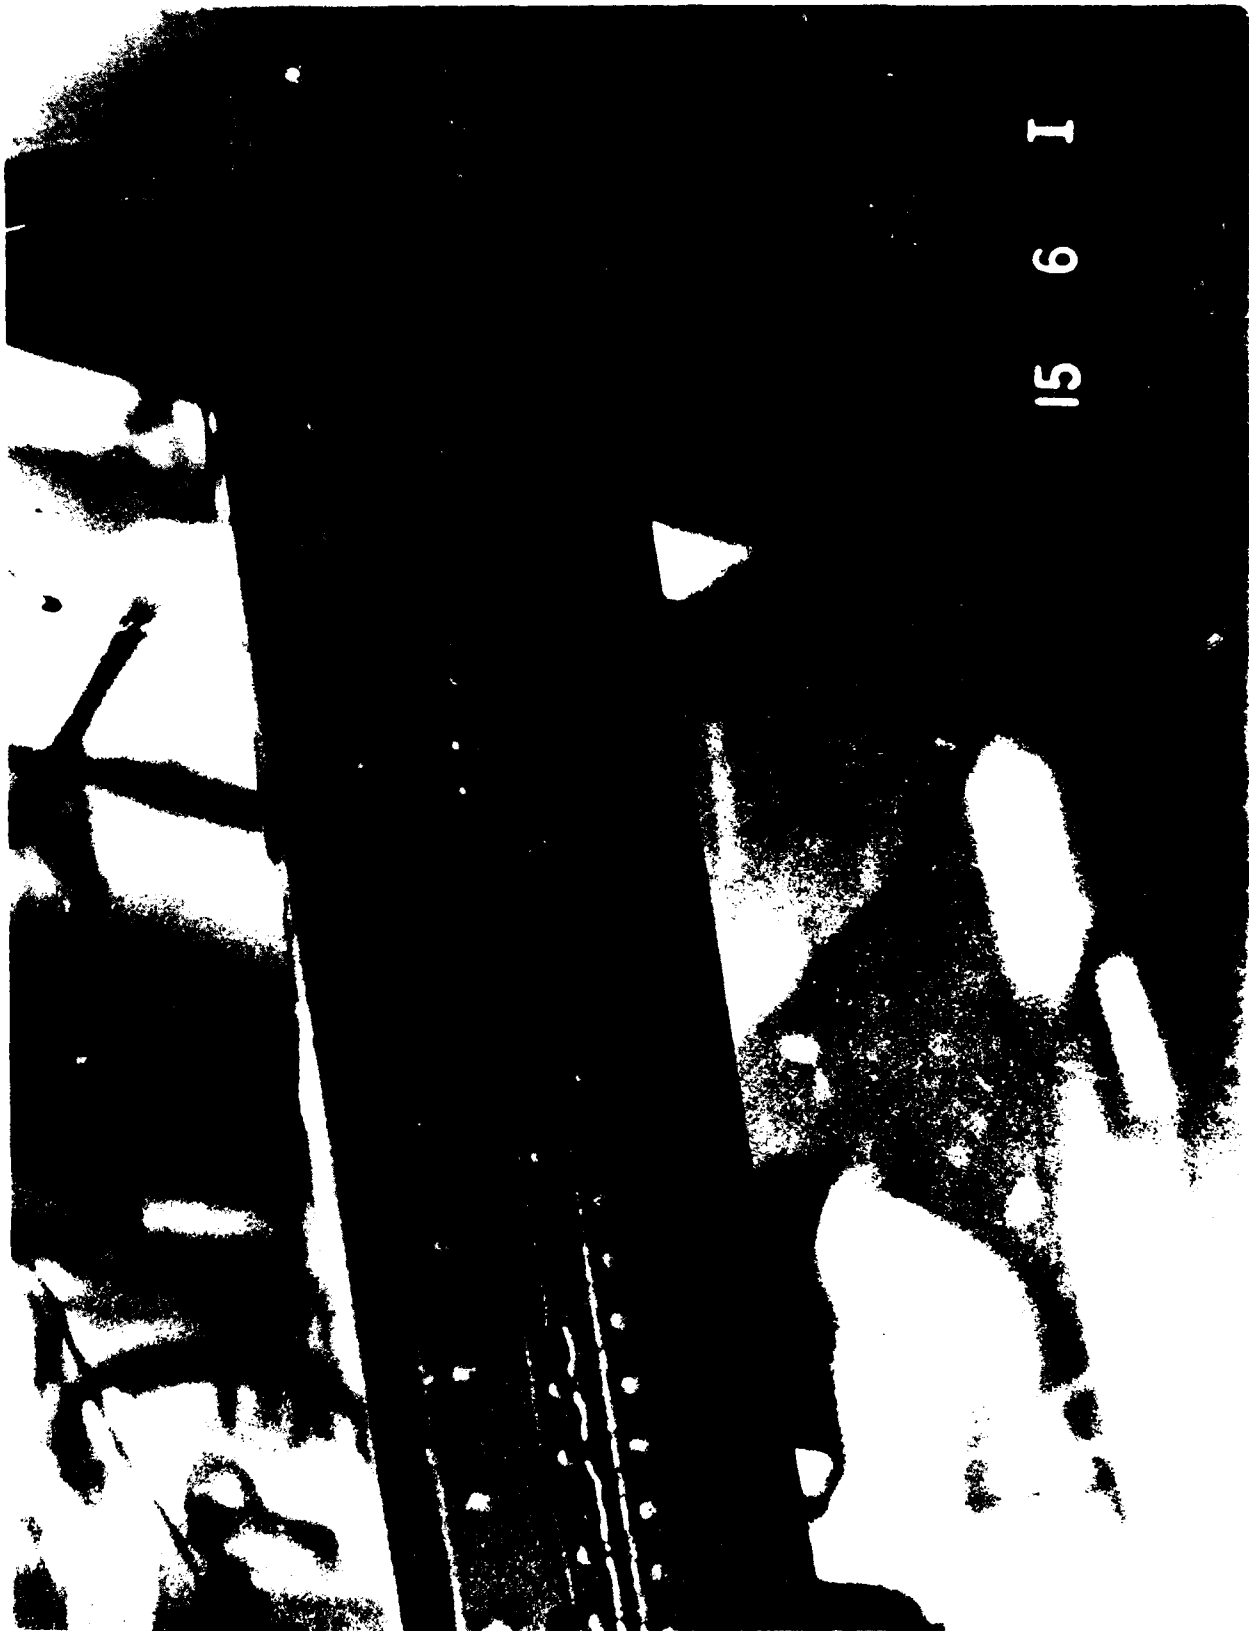
Photograph #12. Attachment Hinge  
Post-Test Shot #156

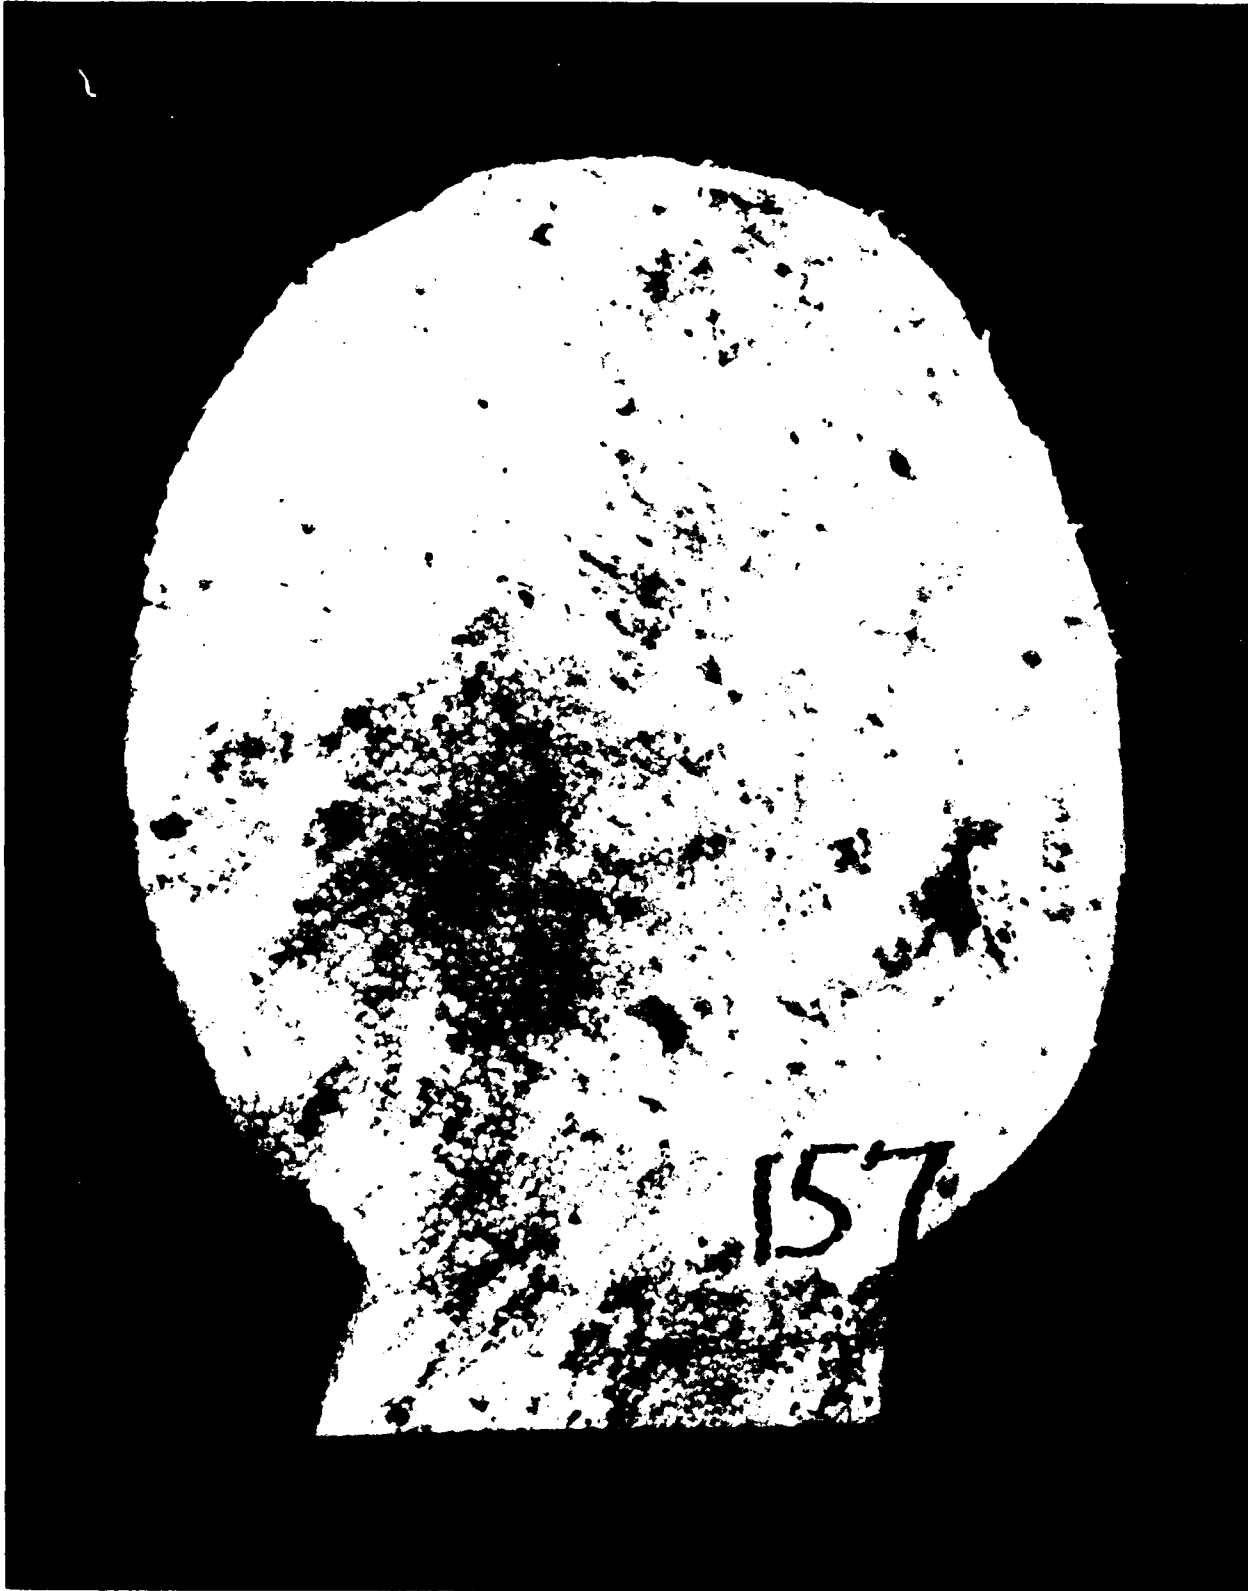
Photograph #22. Witness Plate Head  
Post-Test Shot #157

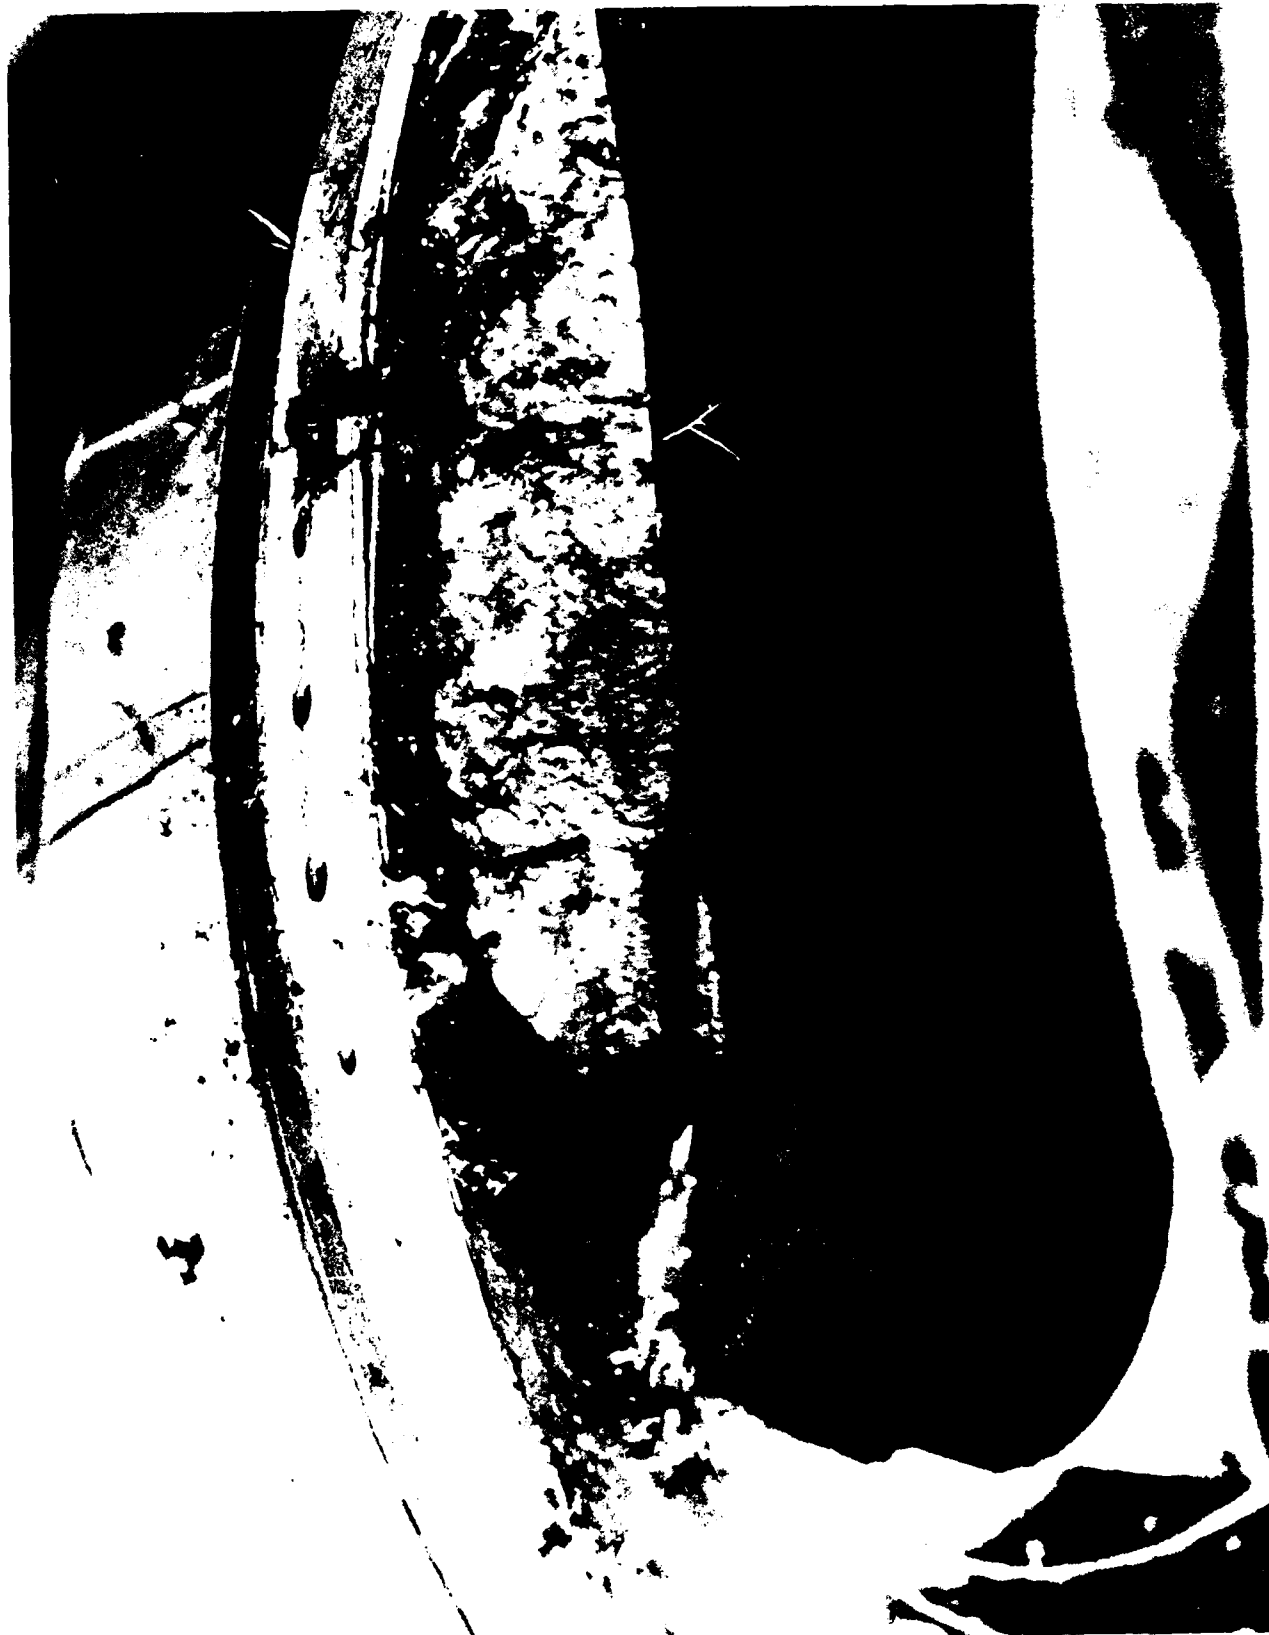
Photograph #29. View Of Aft Arch From  
Aft Shot #160

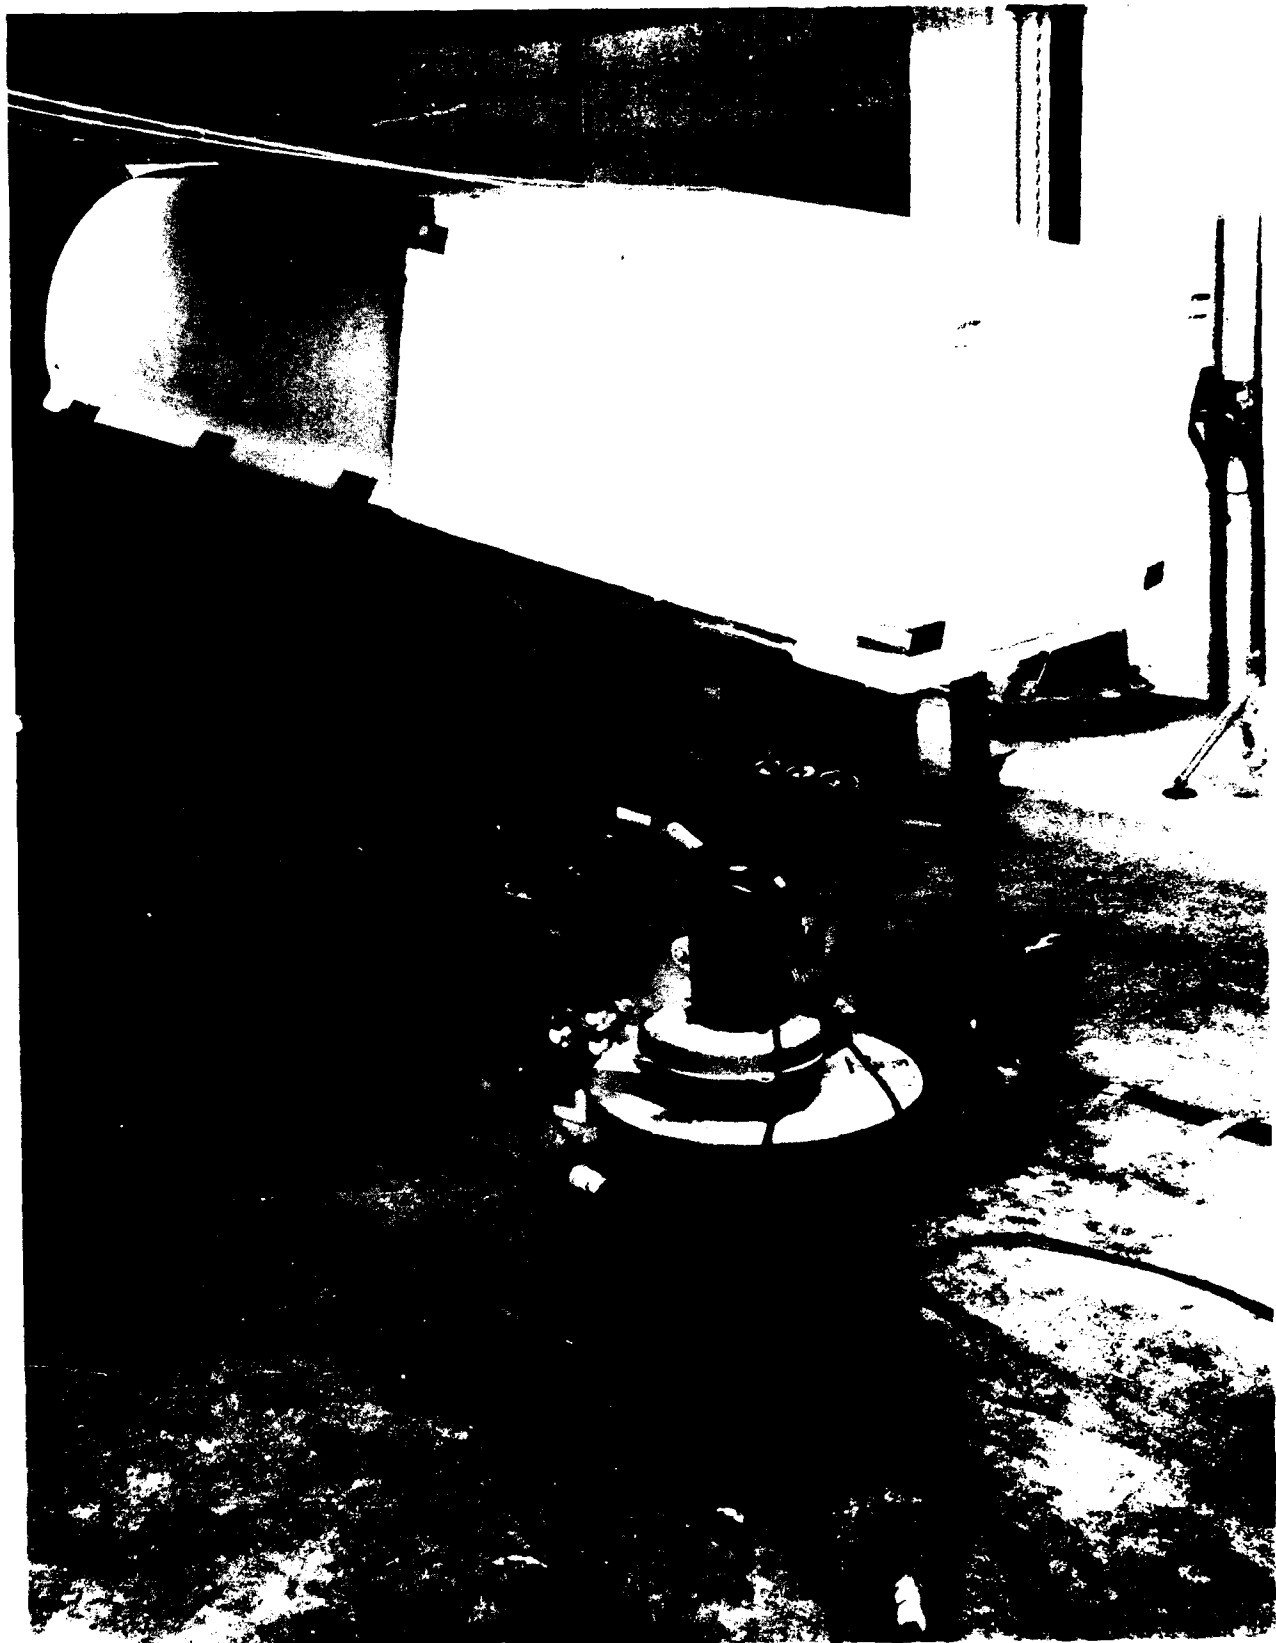
PHOTOGRAPH #1  
COLD SHOT #213  
TEST SET UP

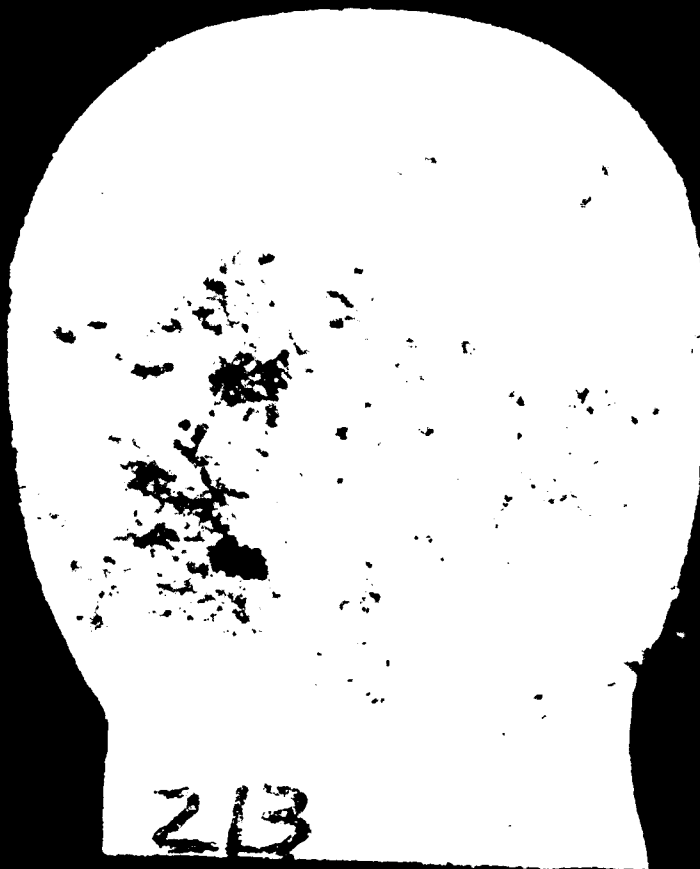
PHOTOGRAPH #3  
COLD SHOT #213  
WITNESS PLATE

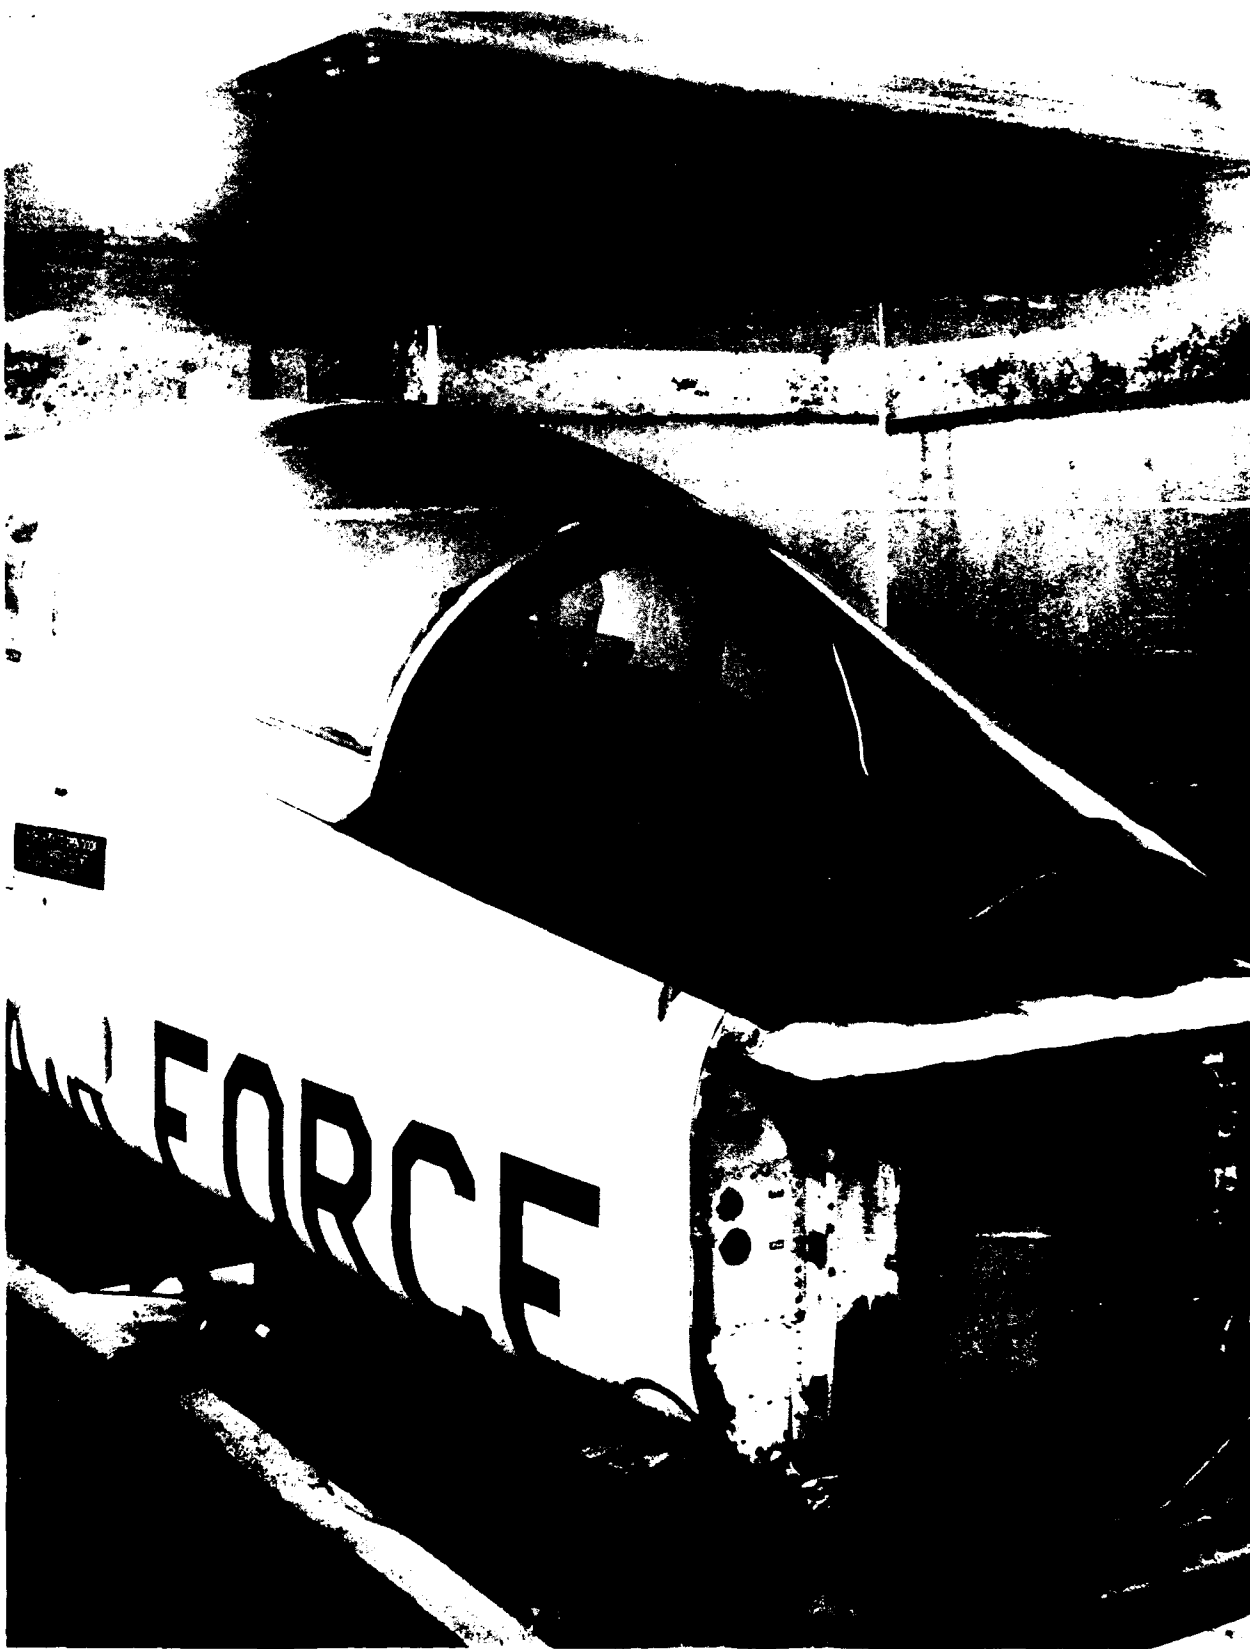
PHOTOGRAPH #6  
SHOT #221  
FUSELAGE SET UP

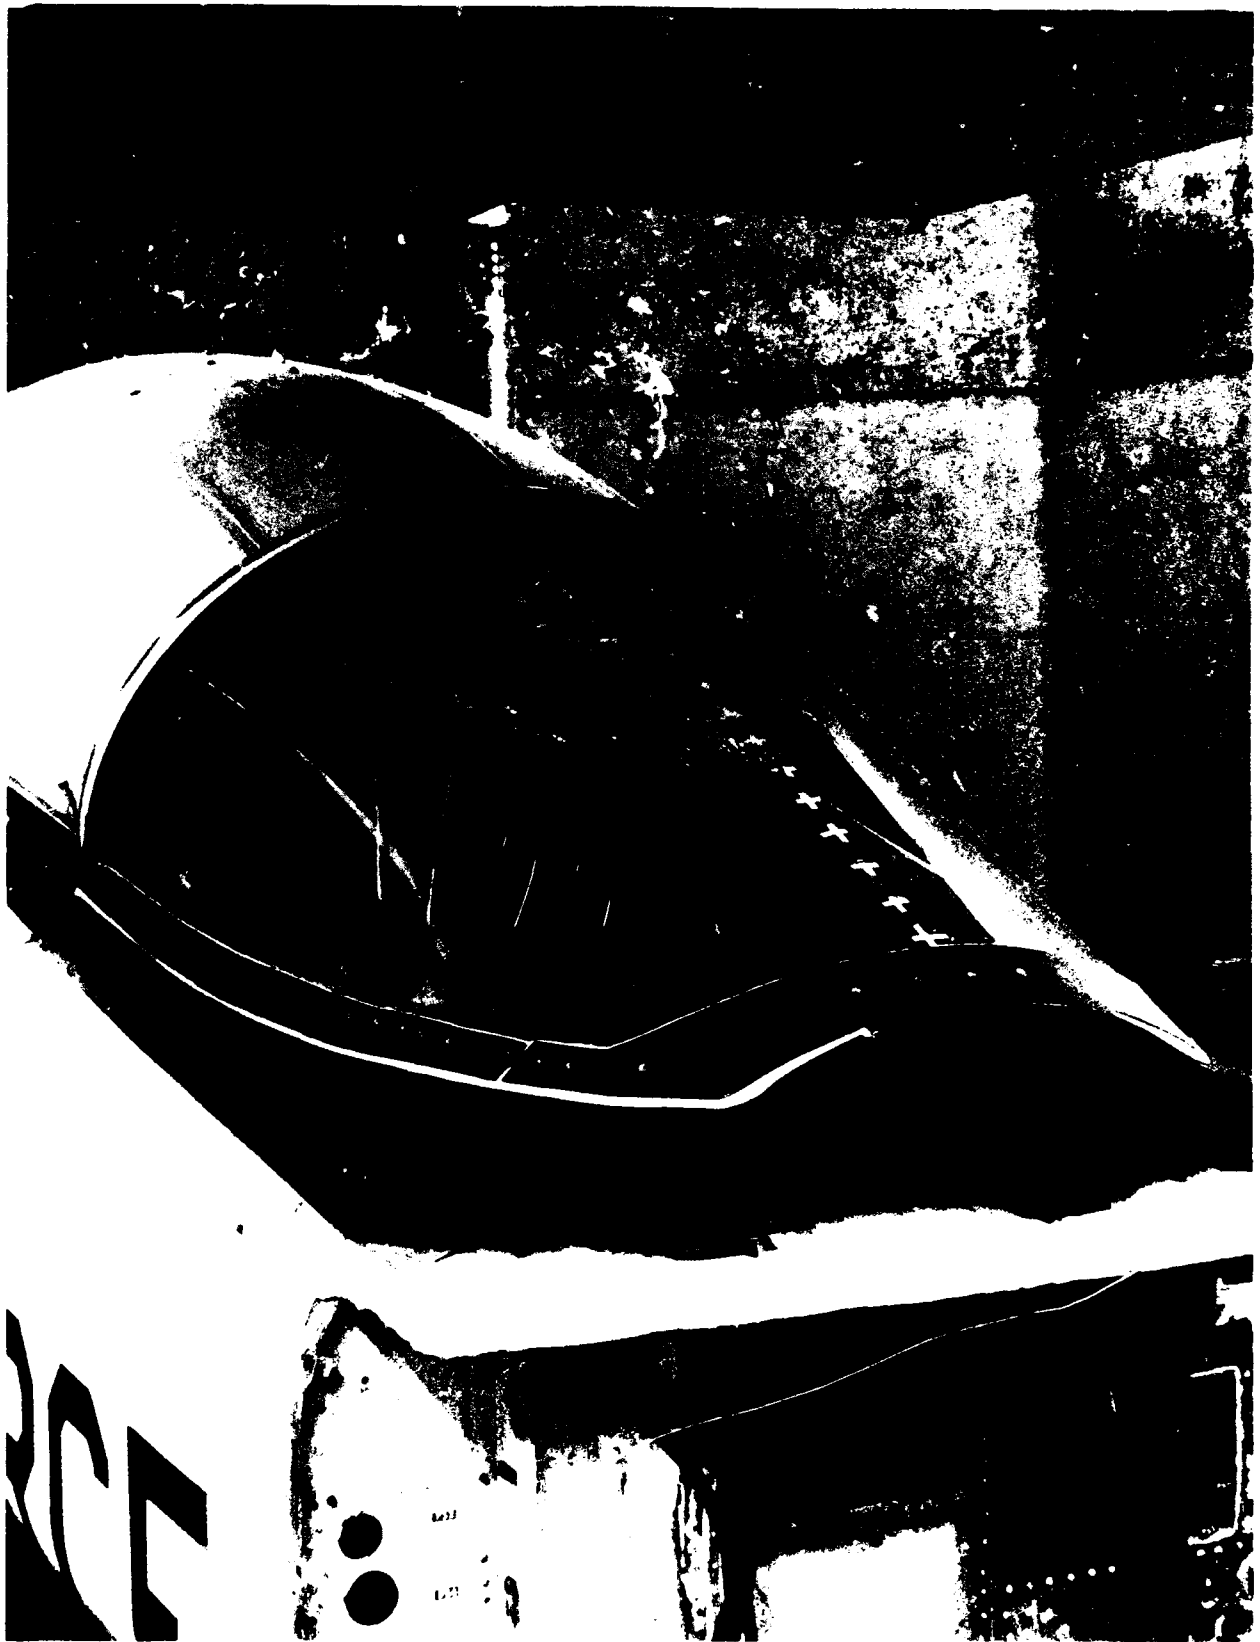
PHOTOGRAPH #16  
SHOT #227  
POST TEST

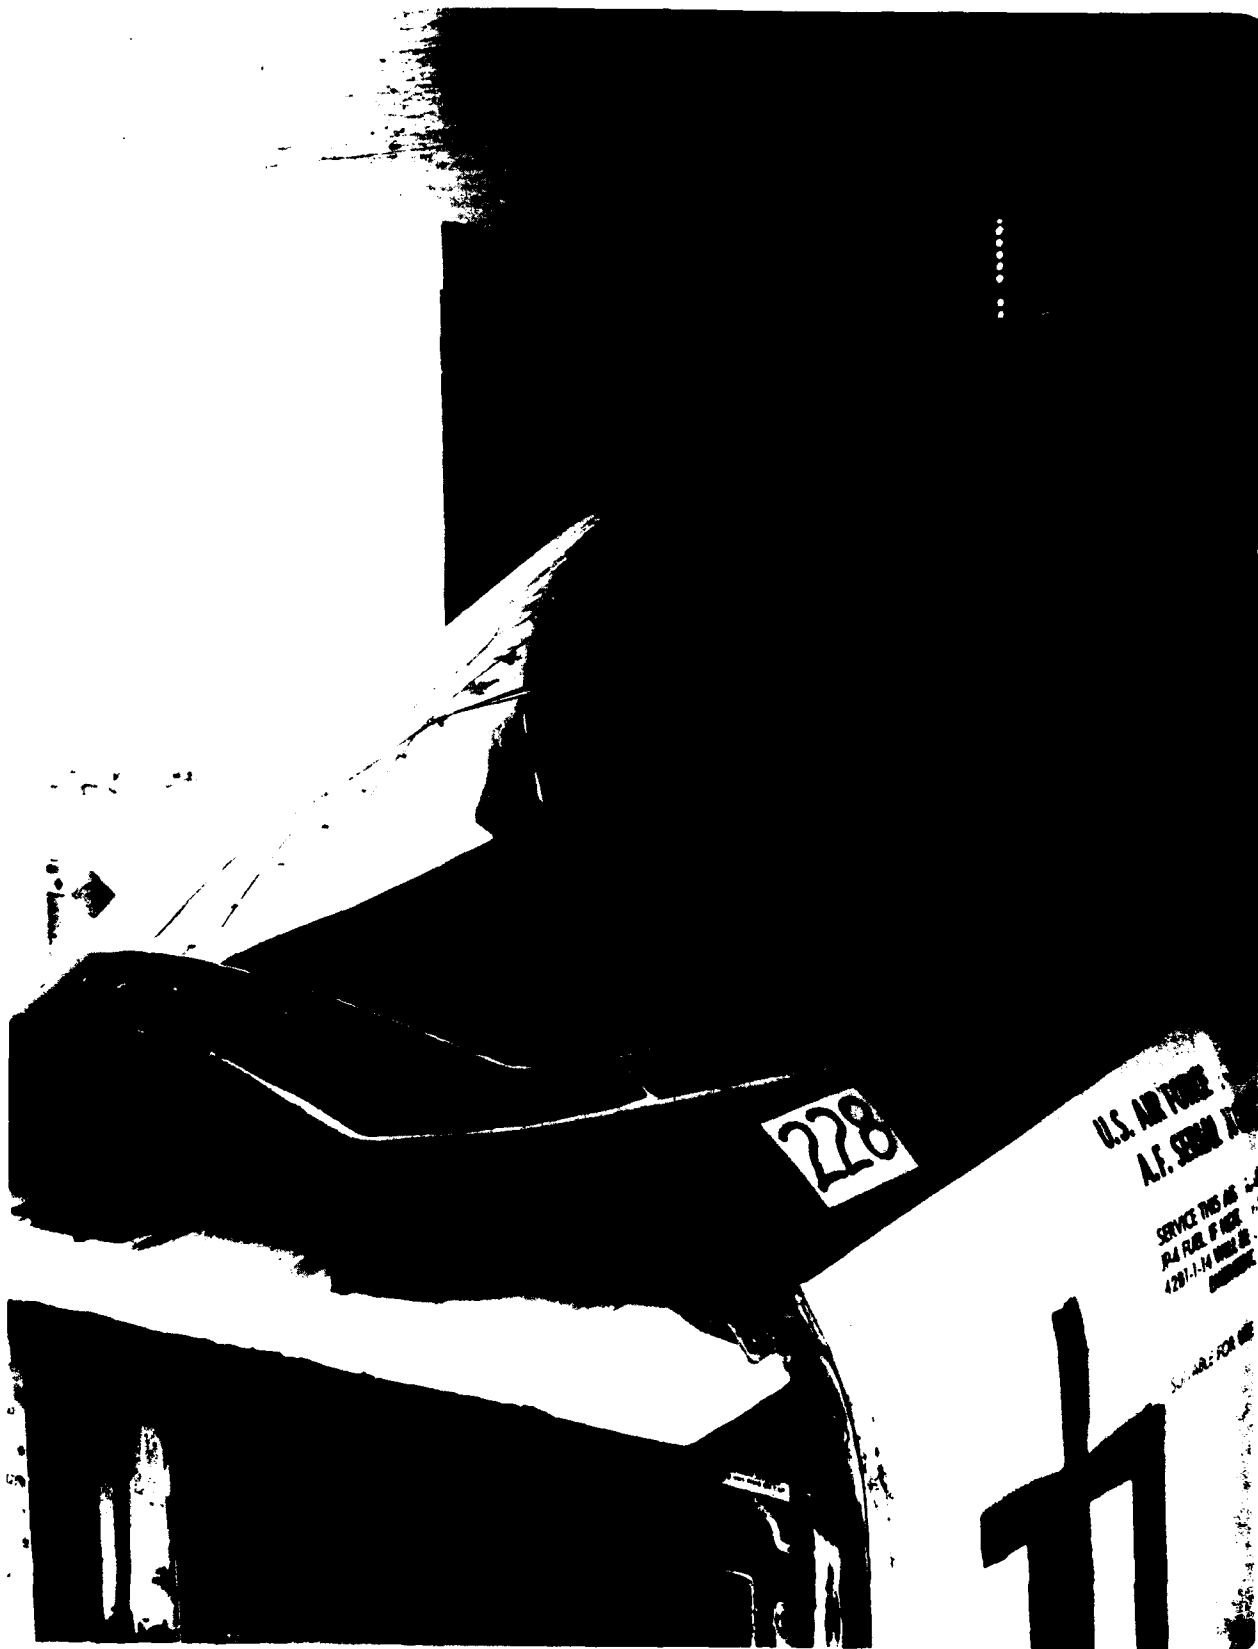
PHOTOGRAPH #17  
SHOT #228  
POST TEST
