**IMPACT RESISTANCE OF
COMPOSITE FAN BLADES**

**E. J. PREMONT
K. R. STUBENRAUCH**

**PRATT & WHITNEY AIRCRAFT
DIVISION OF UNITED AIRCRAFT CORPORATION**

1. Report No. NASA CR-134515	2. Government Accession No.	3. Recipient's Catalog No.	
4. Title and Subtitle Impact Resistance of Composite Fan Blades Final Report		5. Report Date May 1973	6. Performing Organization Code

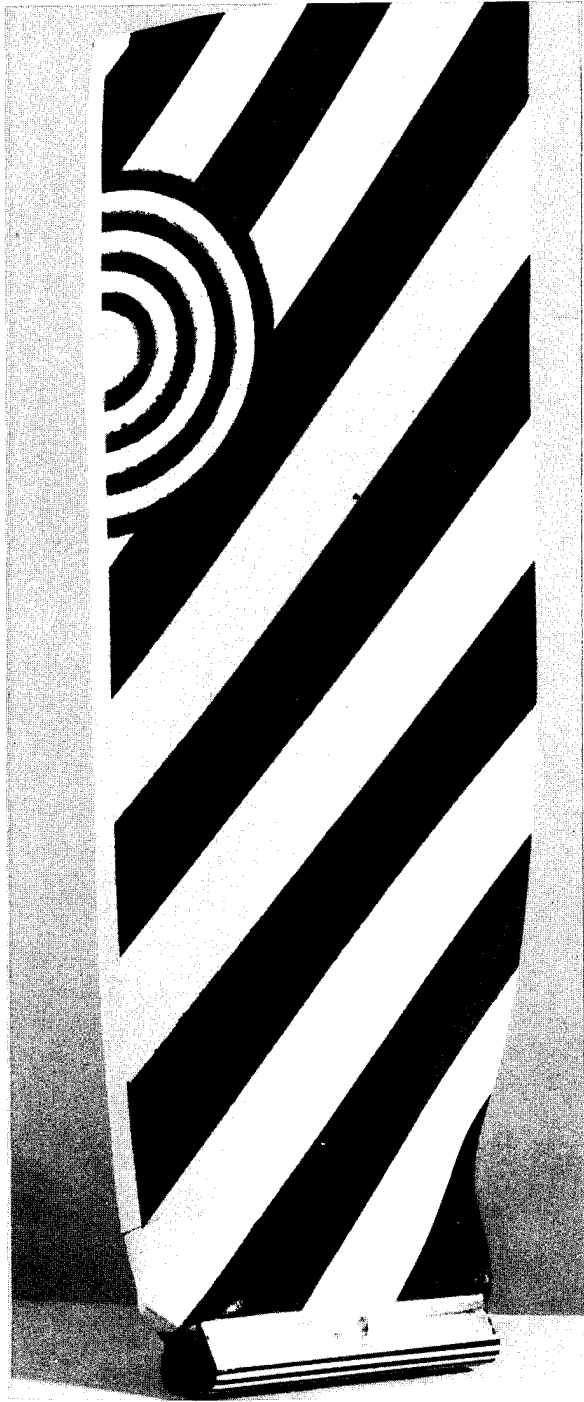
Figure 25 Graphite/Epoxy Blade C-1 Following Impact with Ice Ball

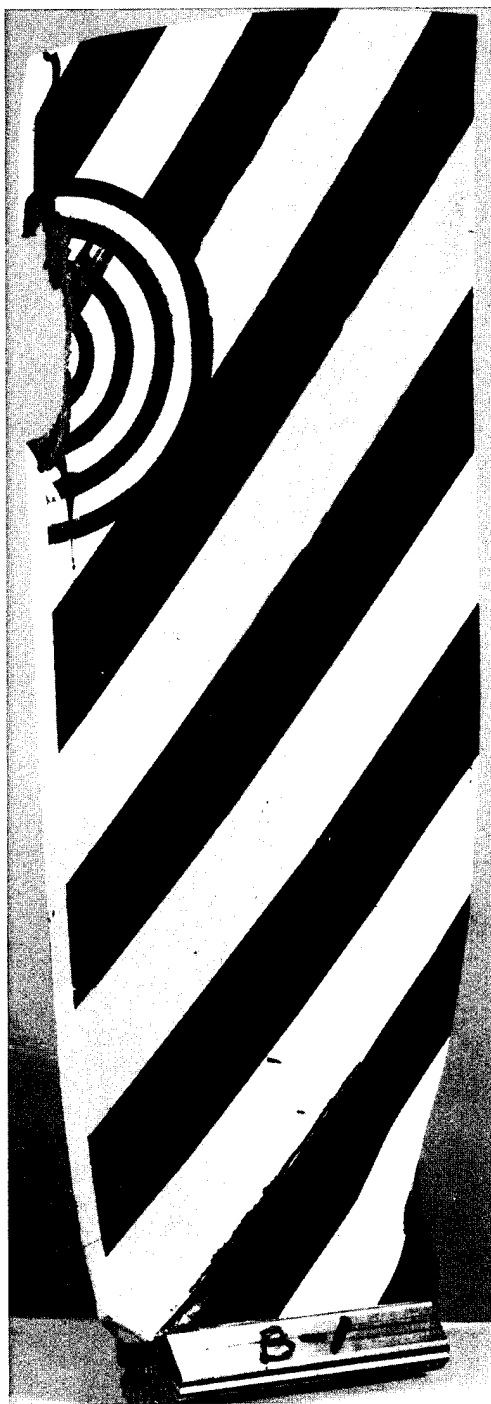
Figure 26 Boron/Epoxy Blade B-1 Following Impact with Ice Ball

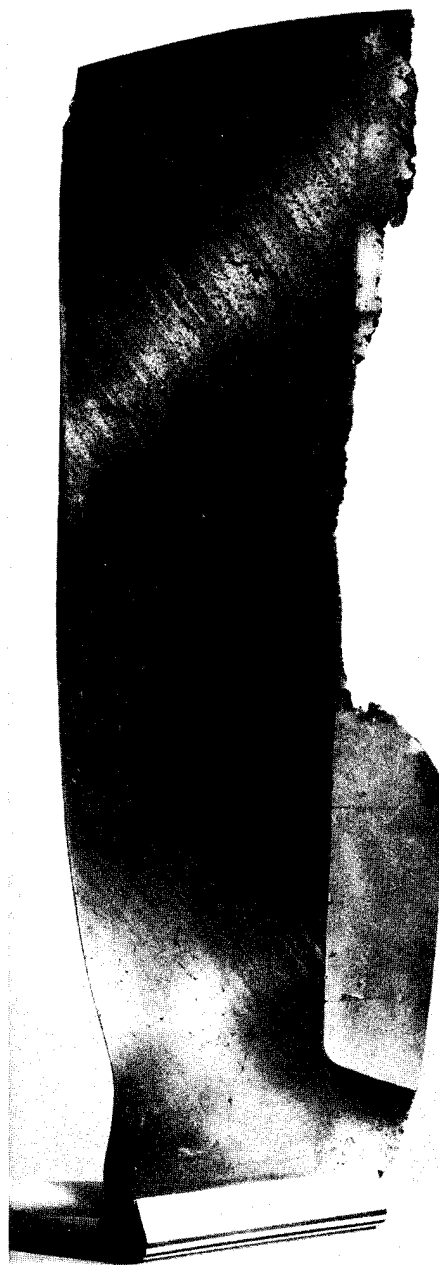
Figure 31 Graphite/Epoxy Blade C-2 Following Two Impacts with 320g Gelatin Ball

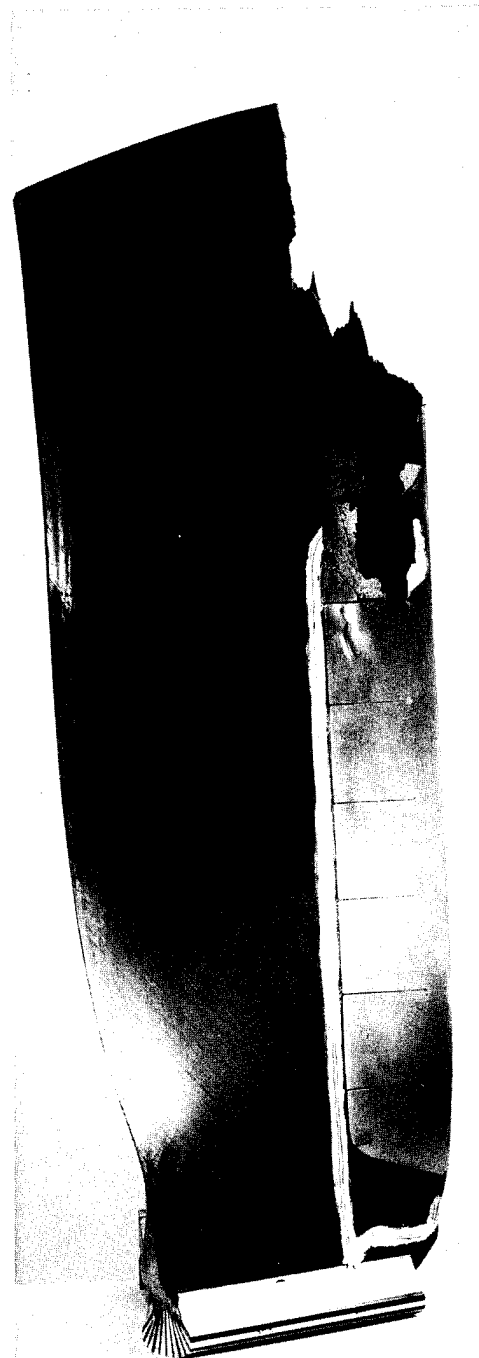
Figure 37 Boron/Epoxy Blade B-3 Following Impact with 165g Gelatin Ball

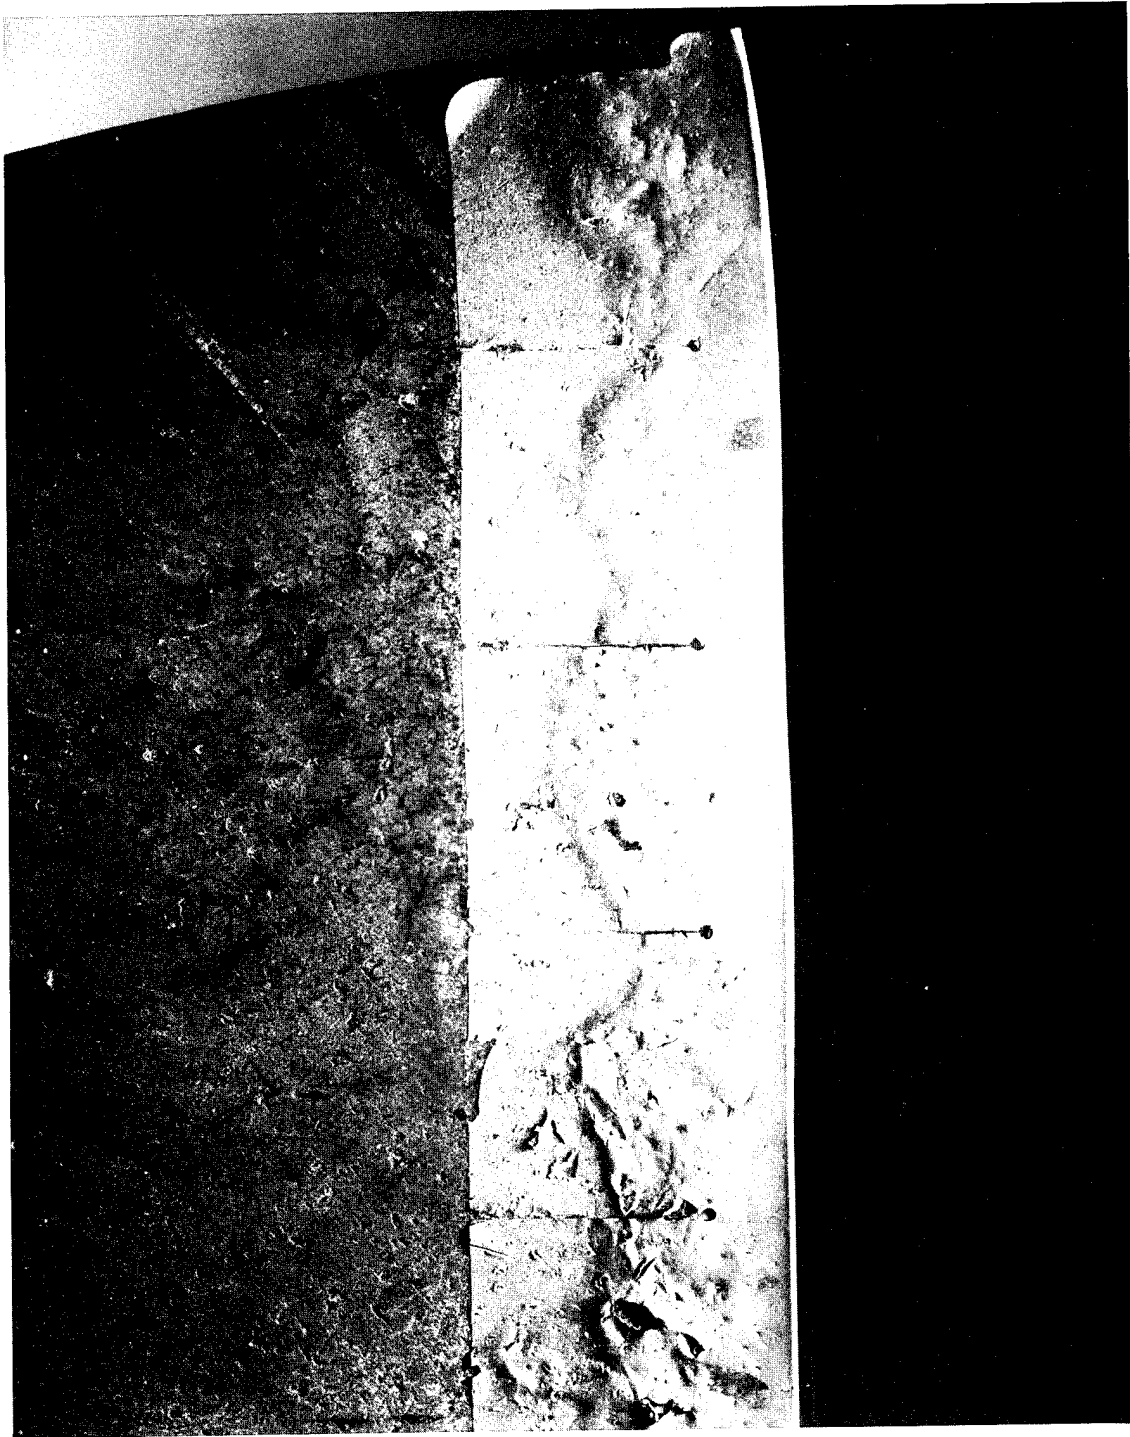
Figure 49 Boron/Epoxy Blade B-4 Following Impact with Gravel

The gravel impact results on blade B-4 are shown in Figures 47 and 48. No ultrasonic indications were found after testing. Damage at the leading edge is negligible, even though the high-speed movies show that impacts did occur at this location. However, the concave side sheath, aft of the leading edge, was nicked, gouged, and unbounded, as pictured in Figure 49. The gravel apparently strikes the sheath causing compressive stresses on the sheath exterior surface. The stress differential within the sheath is great enough to break the sheath-to-blade bond and then lift the sheath from the surface of the blade. Therefore it is concluded that with a better bond between sheath and blade, the leading edge sheath could offer satisfactory protection from small amounts of gravel ingestion.
