# ***GALLIPOLIS LOCKS AND DAM***

**FOUNDATION REPORT**

**VOLUME 4 PHOTOGRAPHS**

**CONSTRUCTION OF TWO PARALLEL LOCKS AND CANAL**

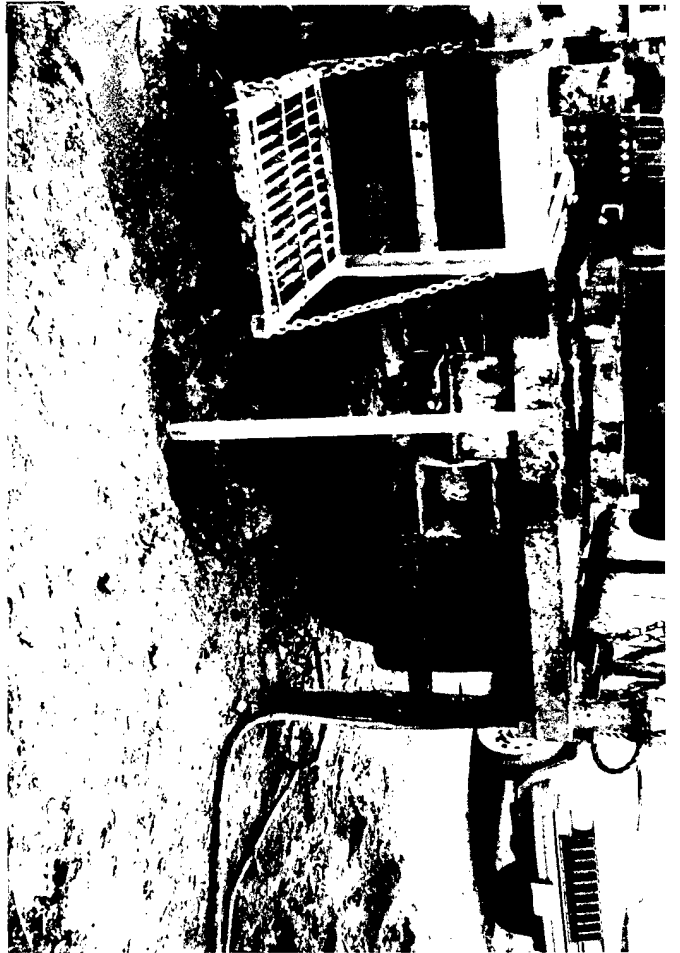
(5) Slurry trench excavation

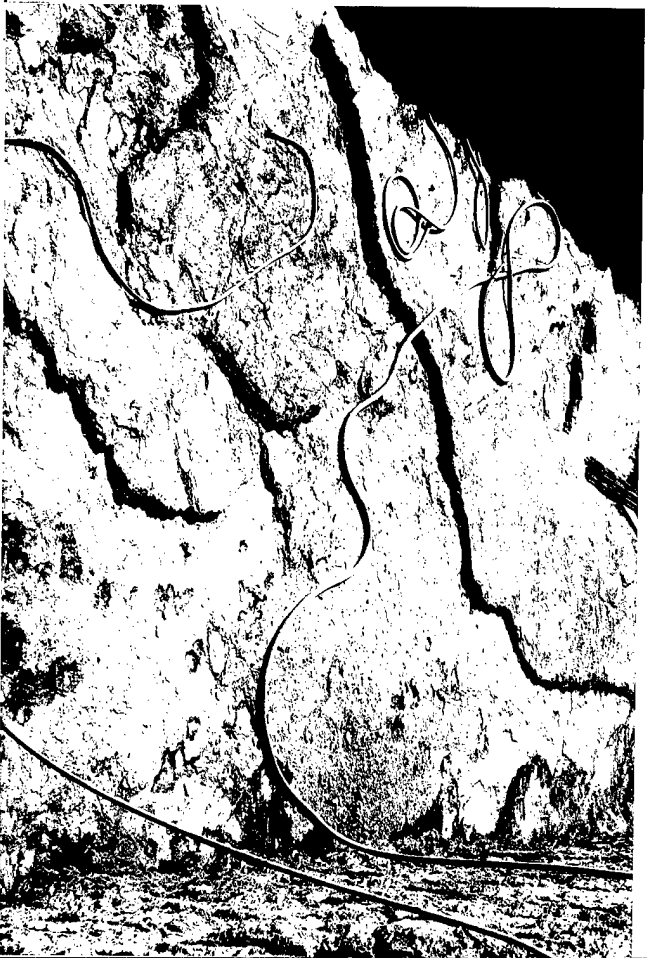
(199) RI-1 Invert view looking East

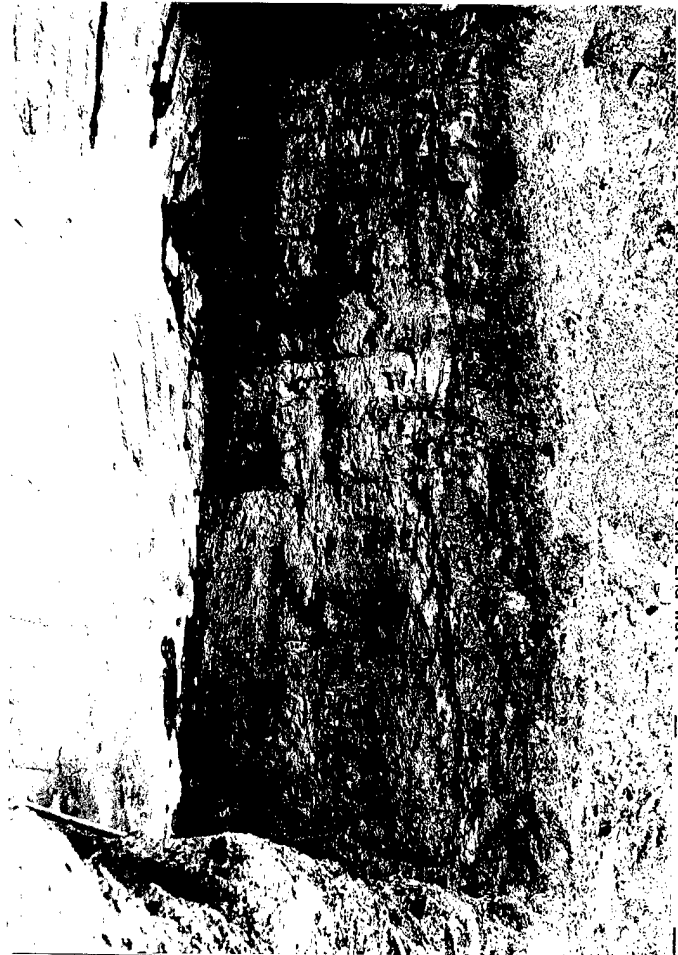
(200) RI-2 View looking West at Invert and End Wall

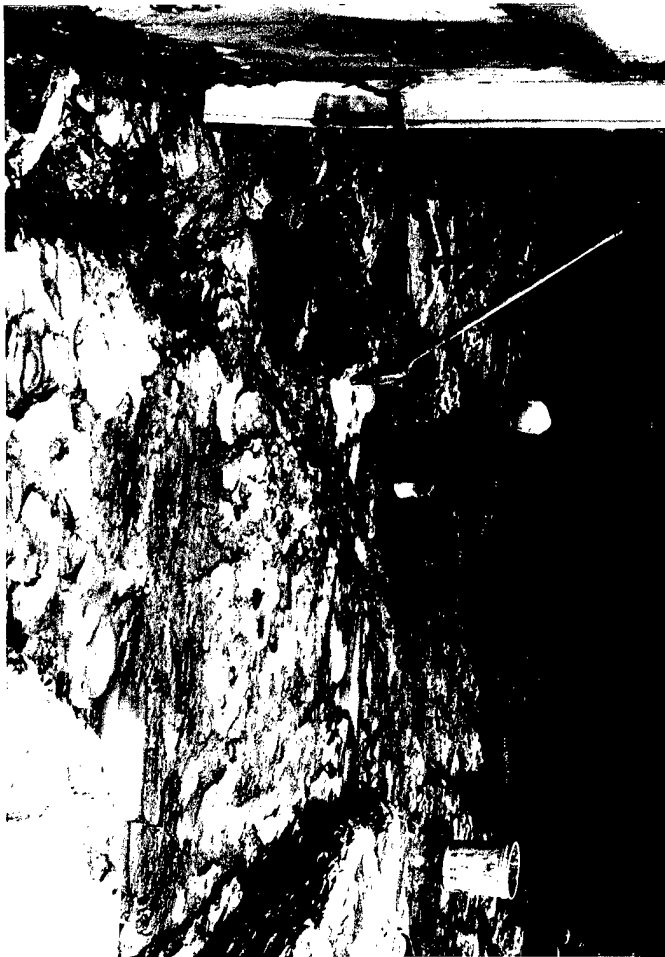
(234) USAMGS-12 Downstream shows slip zone as well as invert  
(236) USAEGS-4 Invert view looking North

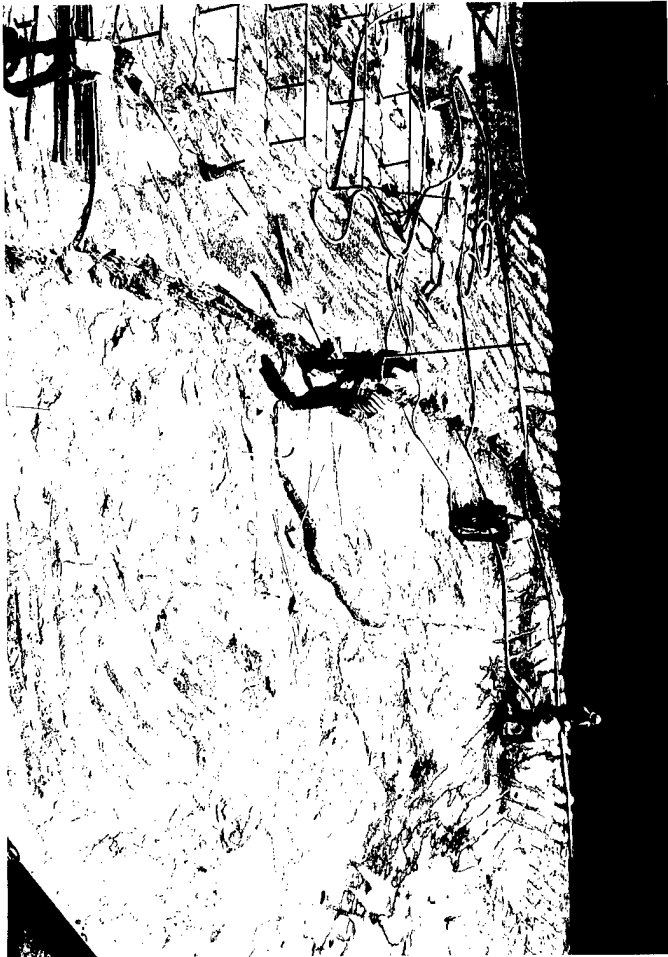
(244) Outlet Structure Invert view looking East

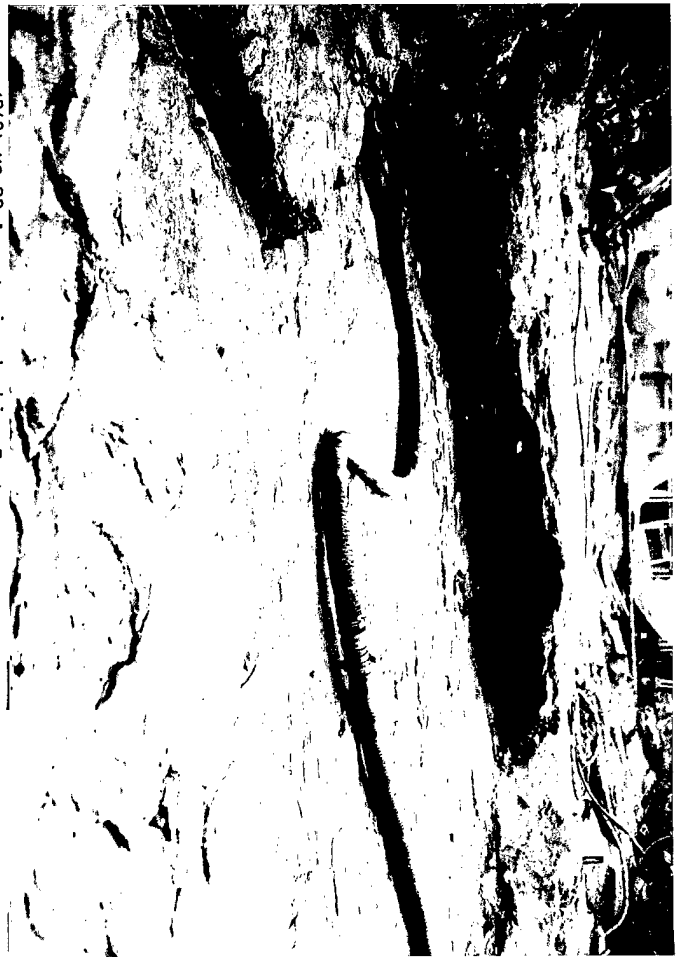
(242) MC-22 Invert view looking East

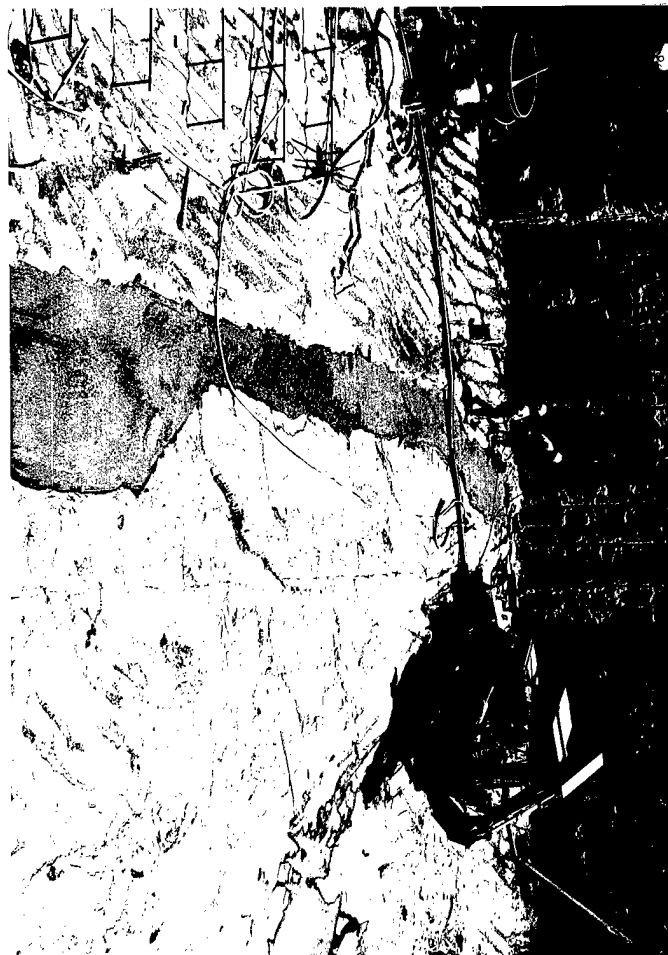
(245) Outlet Structure invert view looking East after repair

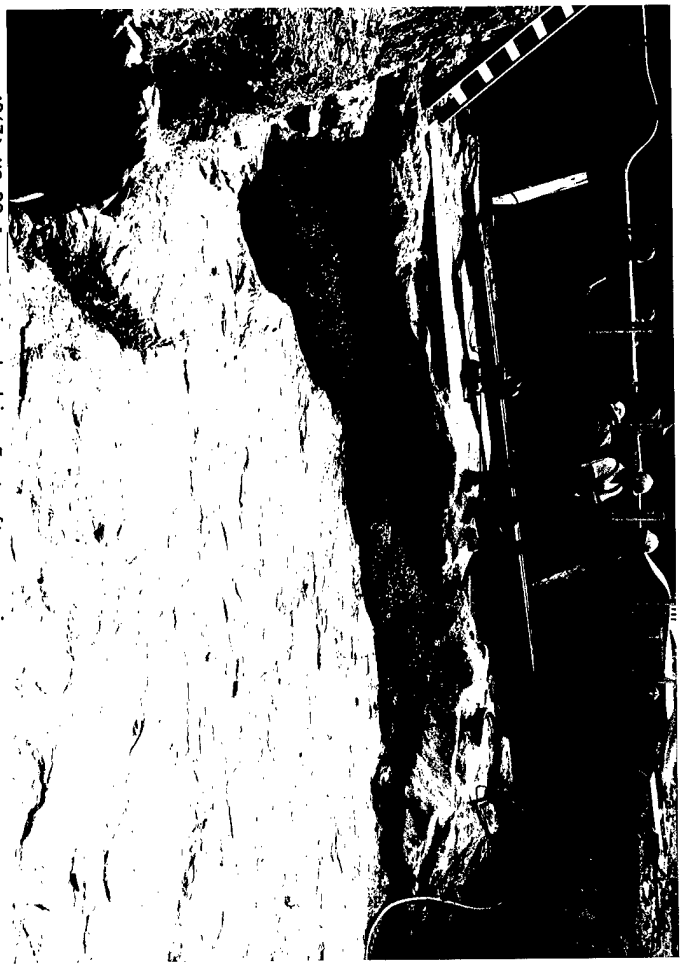
(243) MC-22 Invert view looking East after repair

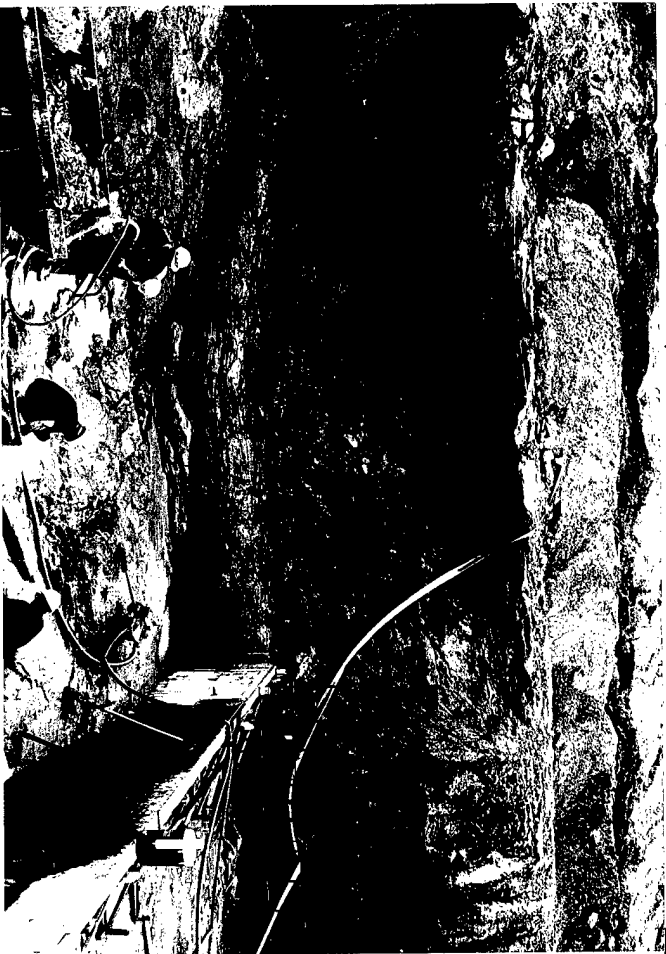
(251) R-37 View along East wall looking South  
(253) M-5 View of West Wall Northern half

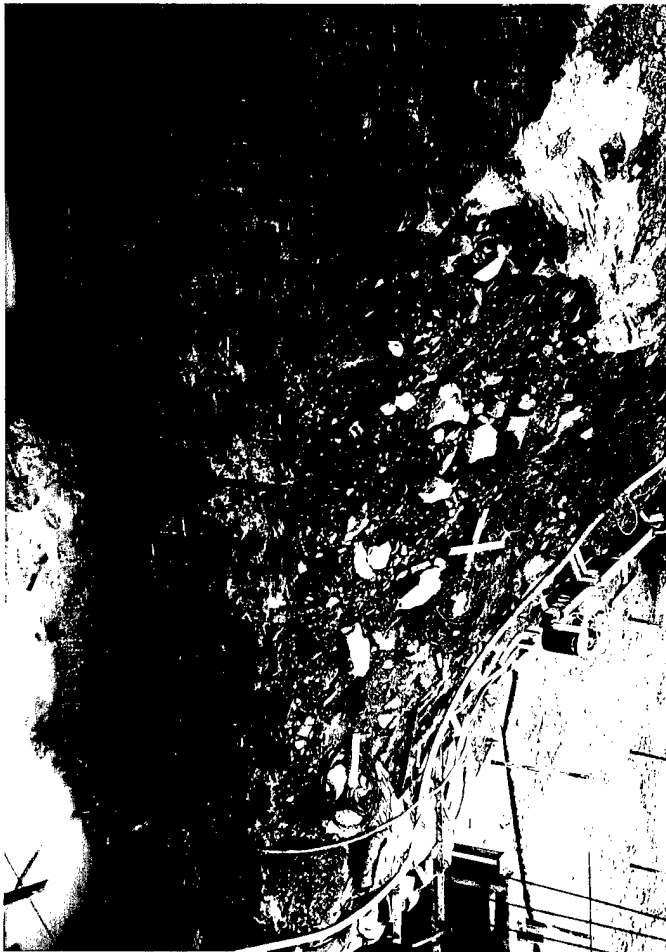
(256) MC-15 View of Southern Wall looking Southwest

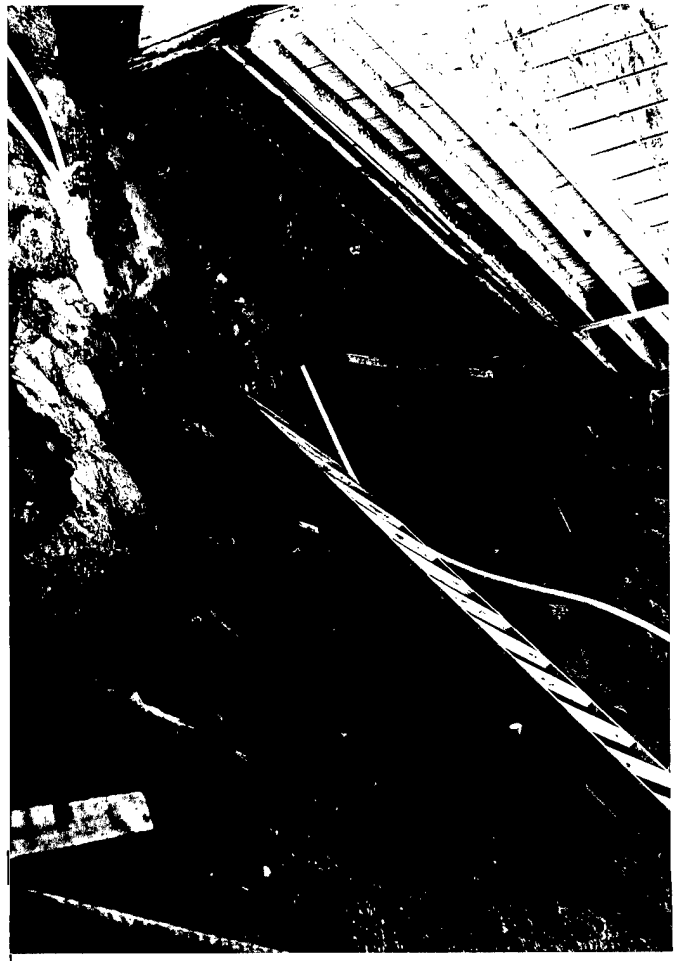
(254) M-12/13 View of East wall looking Northeast

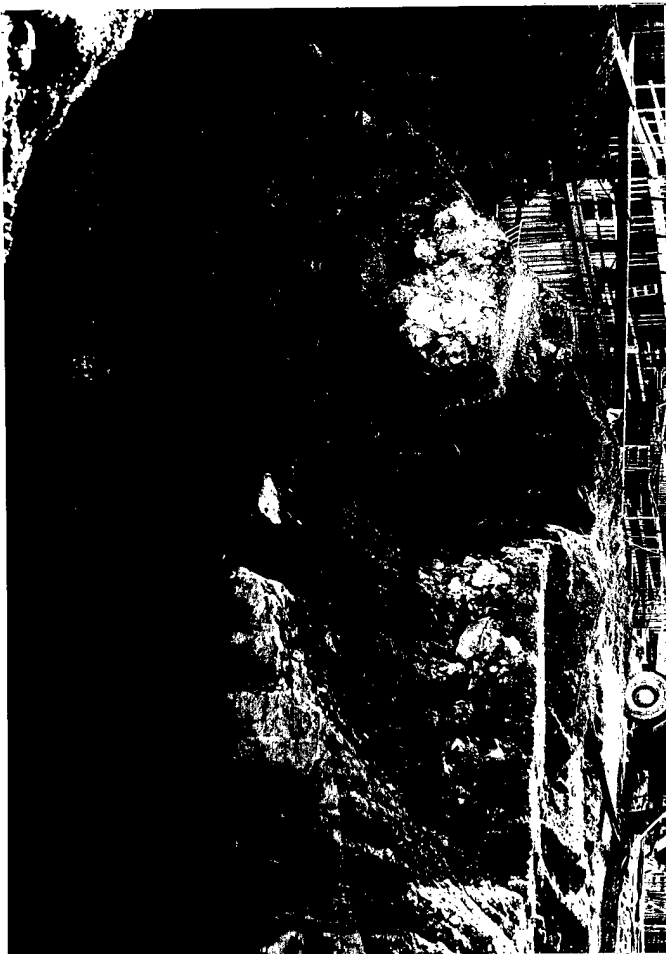
(257) LC-18 View of West Wall looking Northwest

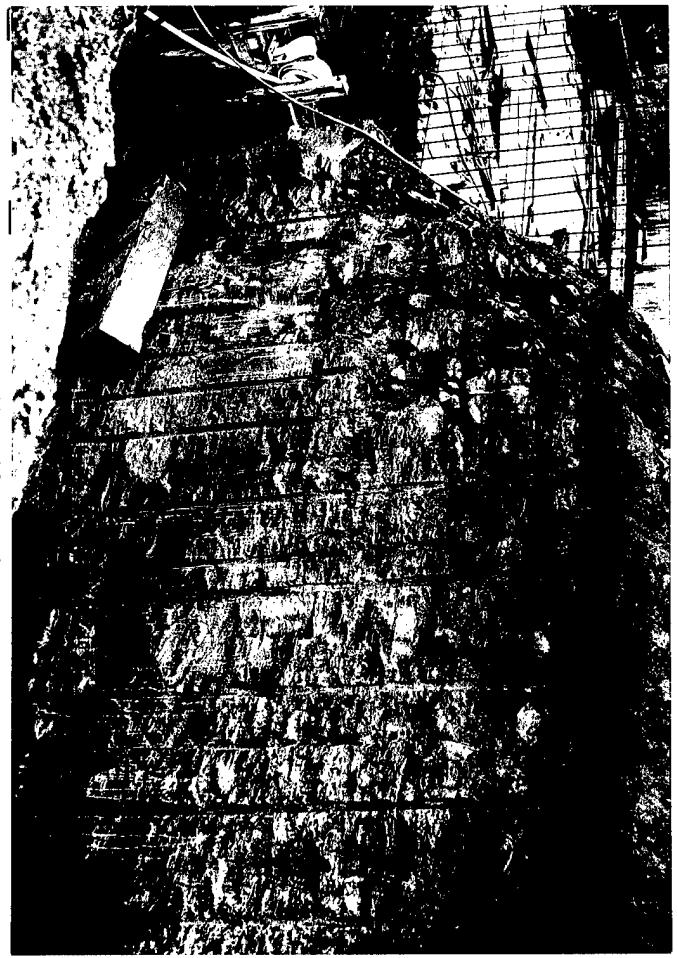
(255) MC-15 View of North Wall looking Northwest

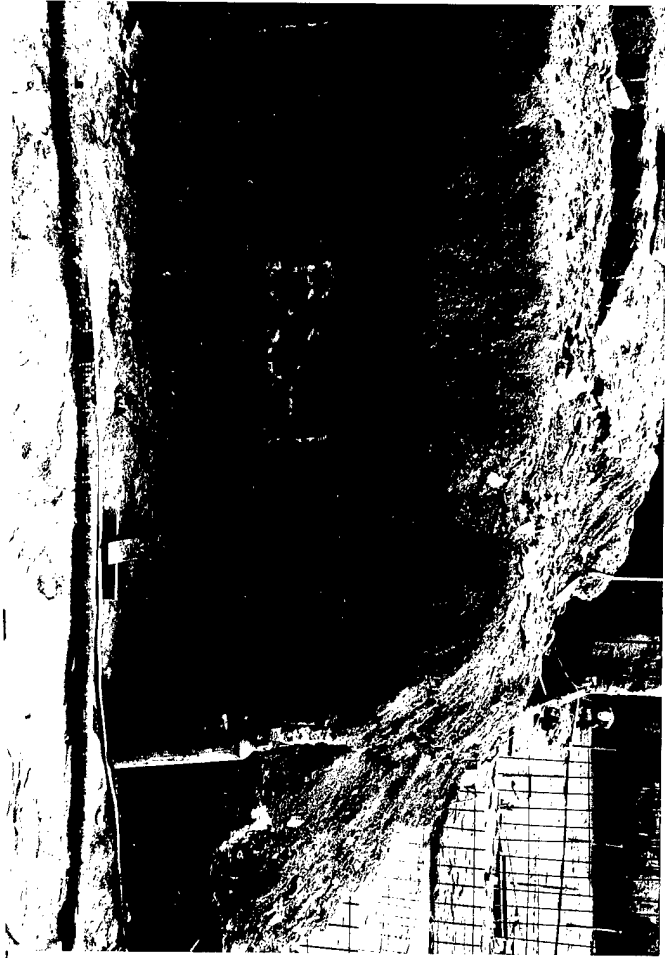
(258) DSMBS-1/R-30 View of corner looking South  
(260) USMEGS-3/M-38 View of corner looking Northeast

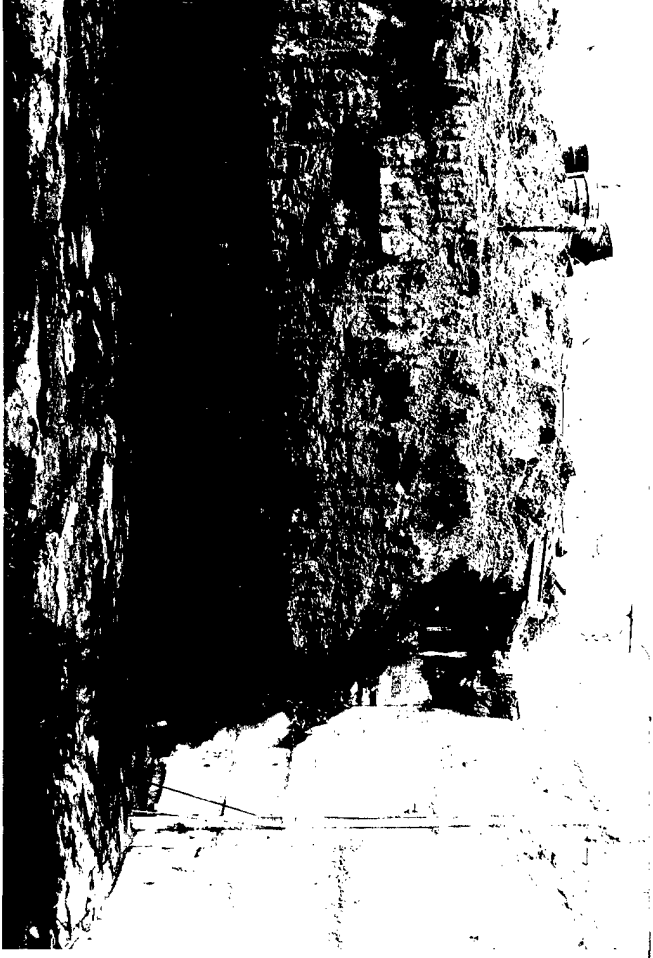
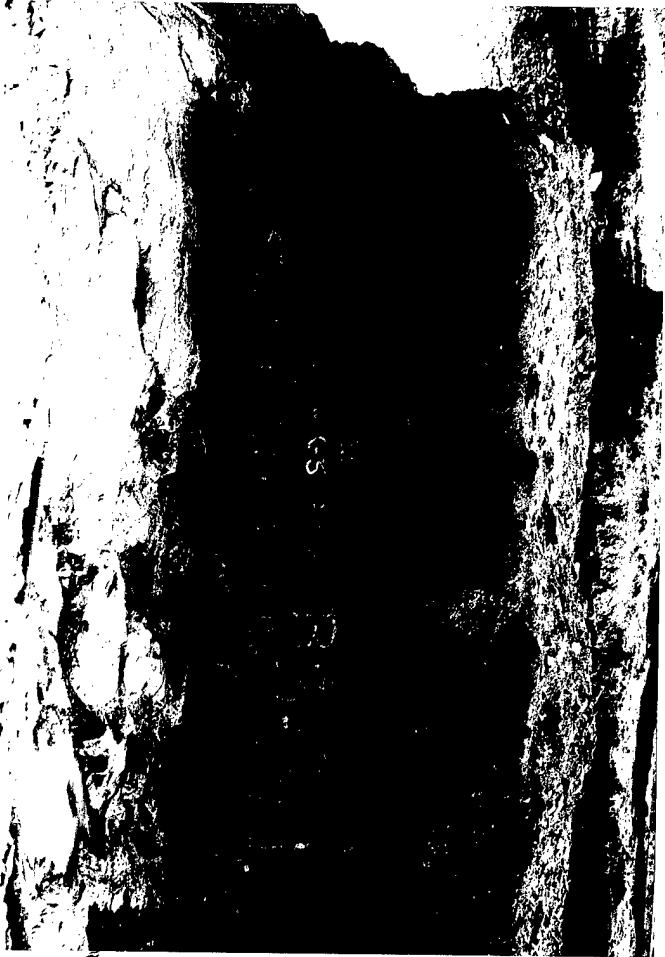
(259) DSMBS-3/M-6 View of corner looking South  
(261) LC-21/22 View along East Wall looking North

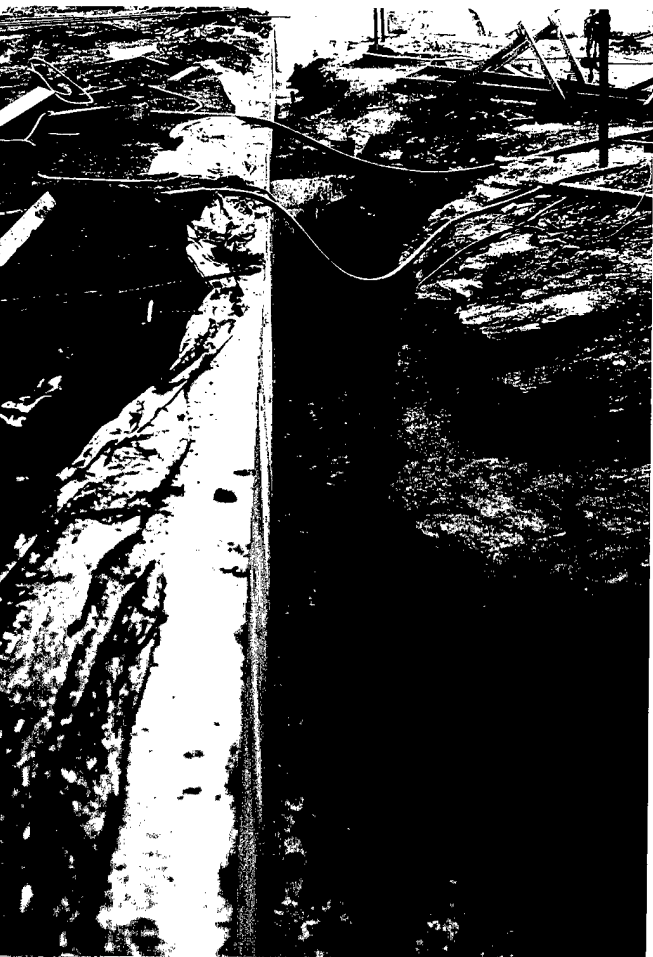
(262) USAMGS-10 View of slip looking Southwest
