February 2001

Mill Creek

Flood Control Project
Radial Gate Investigations

HDR Engineering, Inc.

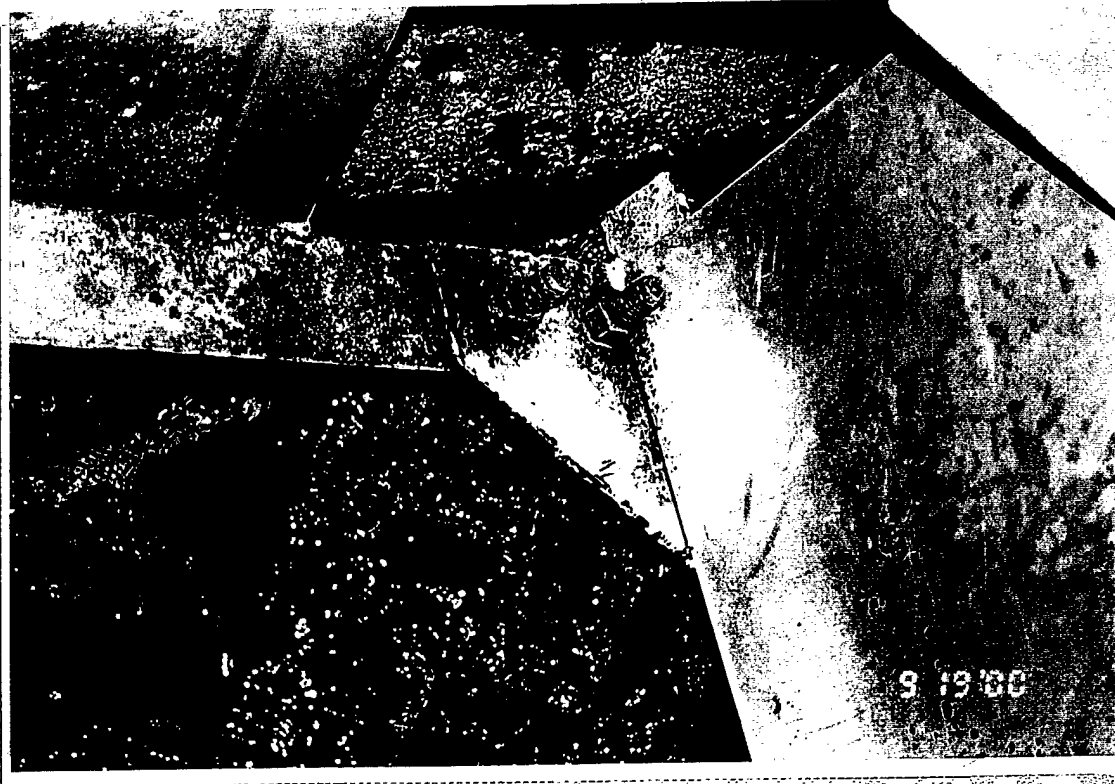
1-10

Armco 6'x14' Gate
Bottom upstream end Strut 1, right
side of gate. Light corrosion on
gusset plate and bolts.

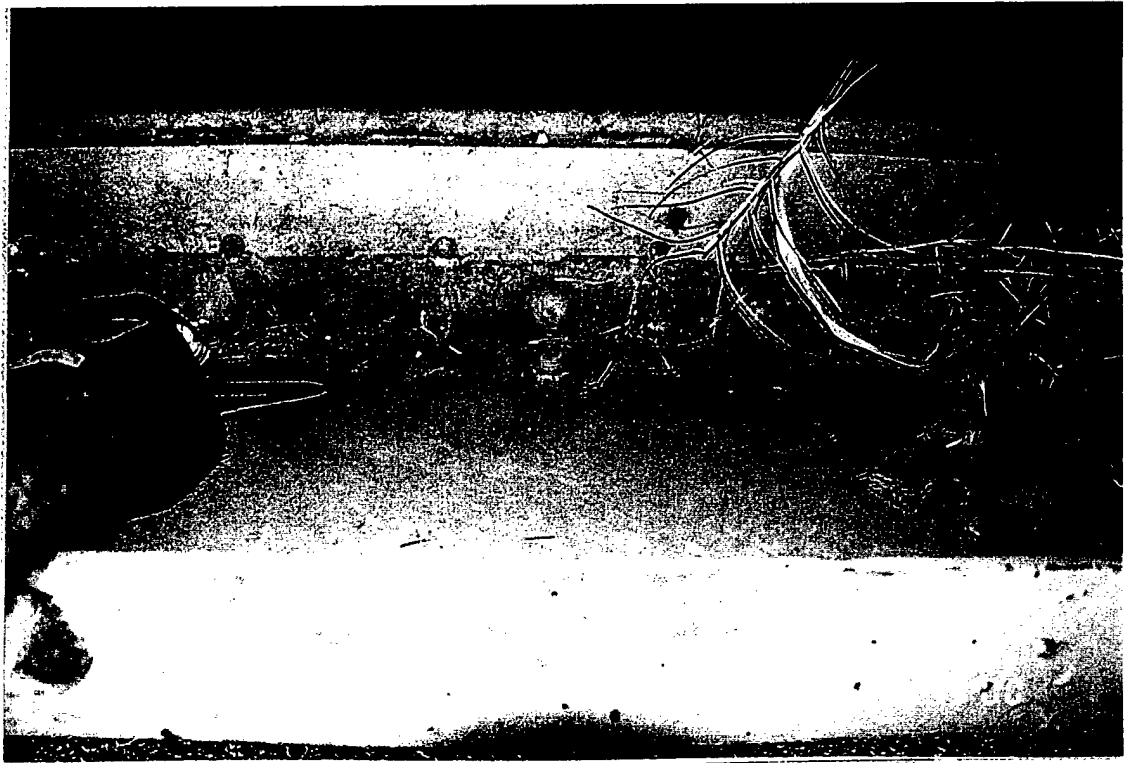
Mill
Creek
Dam
9/19/00
1-9

Gate 1 - 8'x18'
Bottom horizontal girder, looking
upstream. Debris and clogged drain
holes.

- Drainage holes should be provided for the horizontal girders which are rotated to cause ponding against the skin plate. The drain holes should be 1-inch in diameter and spaced at approximately 24-inches along the girders. The edge of hole should be located approximately 1/2-inch from the girder flange. The holes should be drilled, not flame cut (the use of a mag-drill is recommended). If flame cut holes are the only available option, the edges of the holes should be reamed smooth.

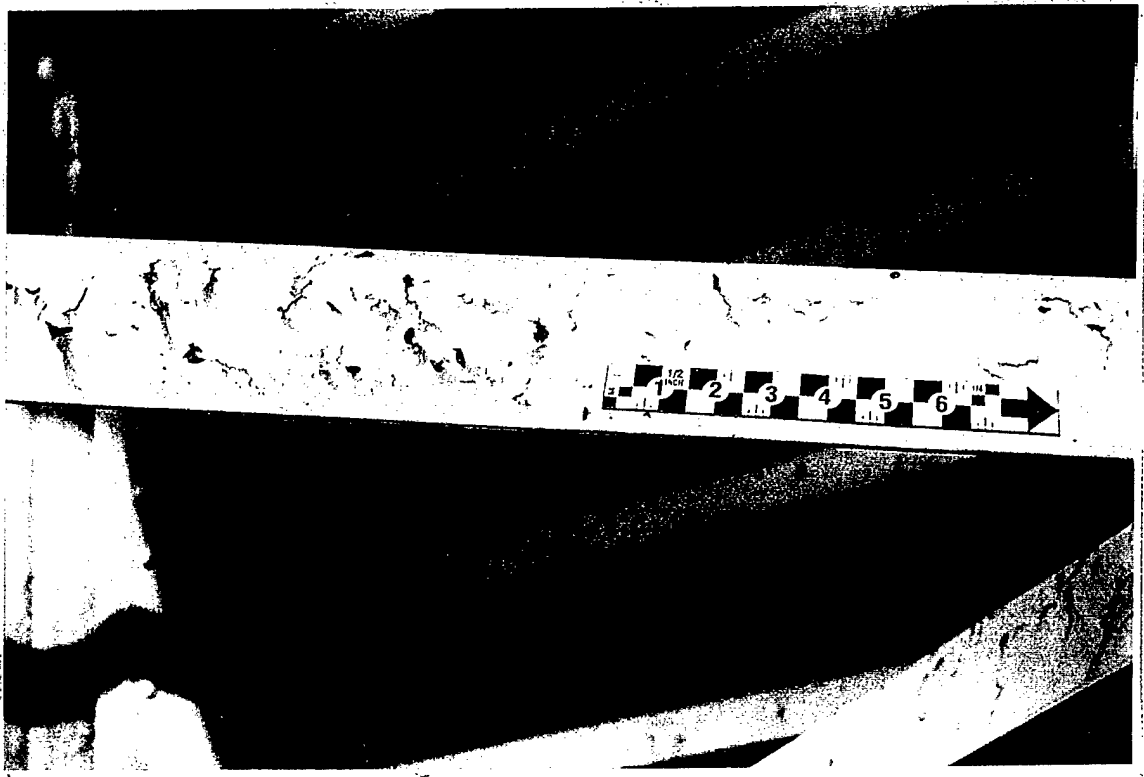
2-2

Gate 2 - 8'x18'
Paint peeling, delamination and light
corrosion on cross bracing, typical.

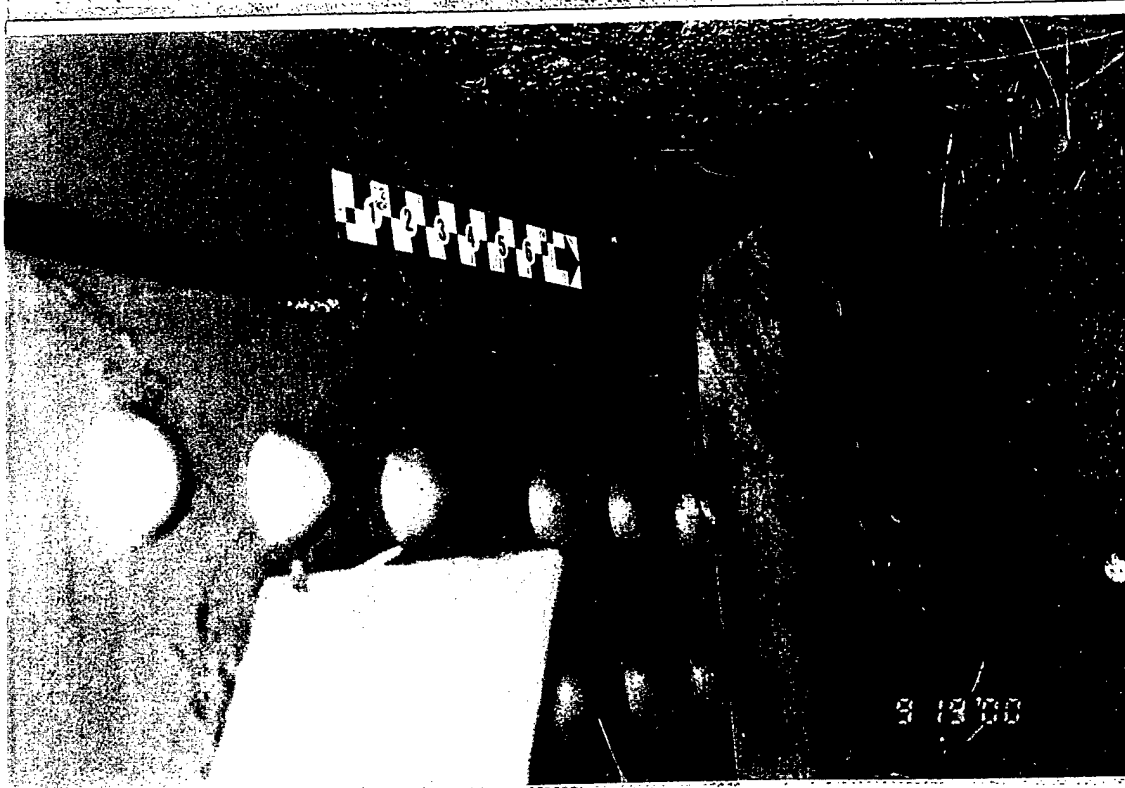
2-4

Gate 2 - 8'x18'
Close-up, bottom left side of gate at
timber bumper. Splitting at end of
bumper, light to moderate corrosion
on bottom strut.

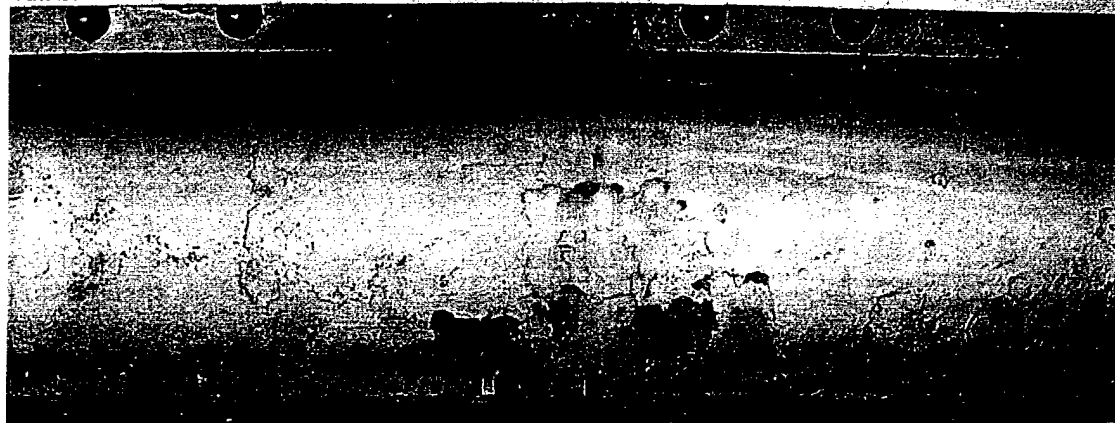
3-3

Gate 3 - 8'x18'
Delaminated paint on skin plate.

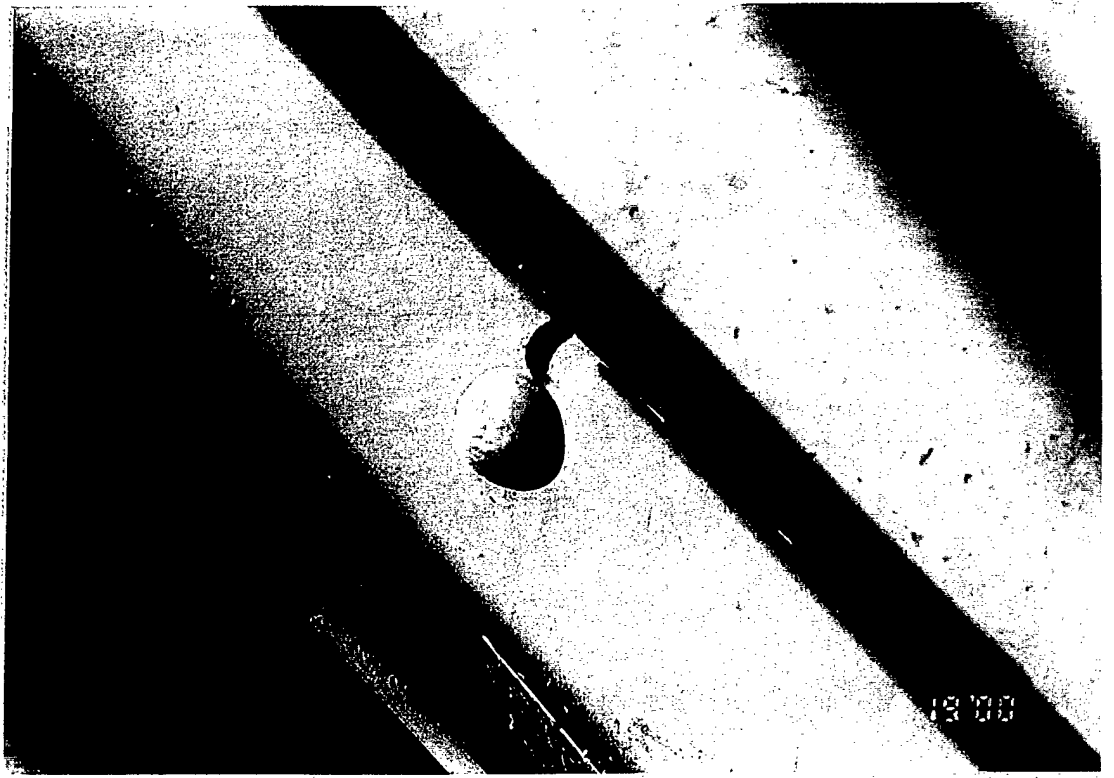
3-13

Gate 3 - 8'x18'
Right frame, bottom strut. Extra bolt
hole punched in angle.

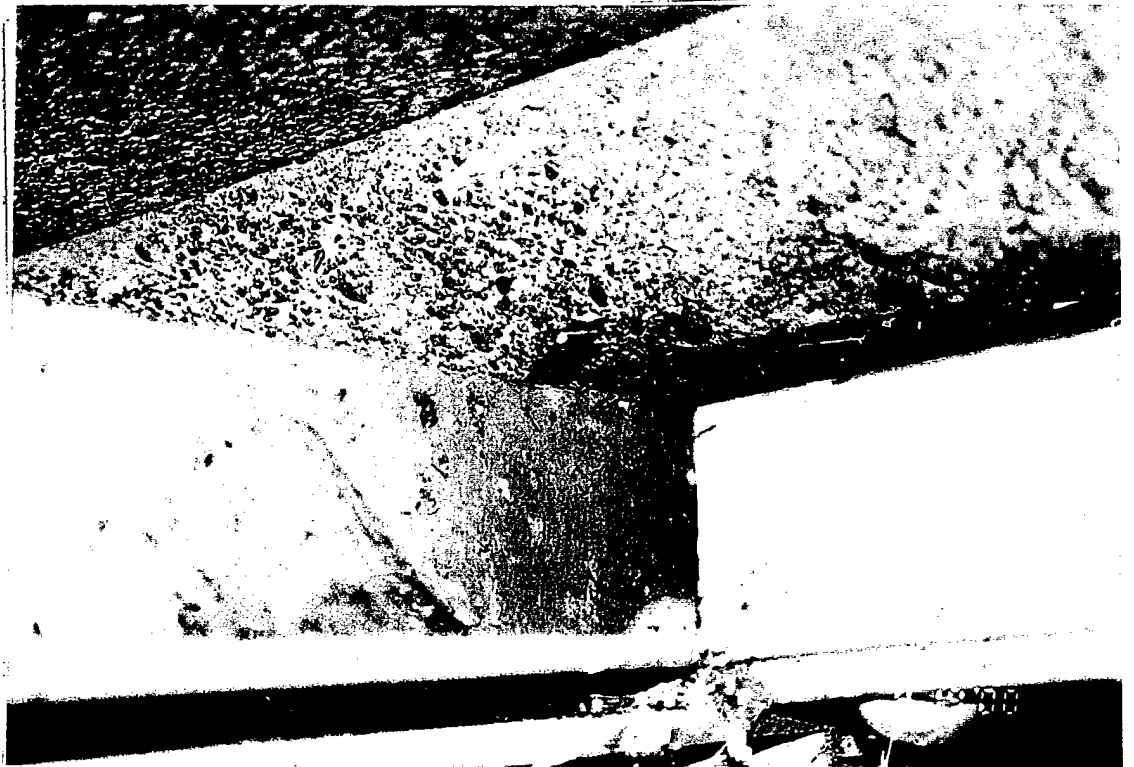
4-14

Gate 4 - 8'x18'
Right frame. Bottom strut and side
plate angle in contact with pier wall.
Note: steel ruler between strut and
pier.
