IRAQI CIVIL DEFENSE
HEADQUARTERS
BAGHDAD, IRAQ

SIGIR PA-06-090
APRIL 26, 2007

SUBJECT: Report on Iraqi Civil Defense Headquarters, Baghdad, Iraq (Report Number
SIGIR PA-06-090)

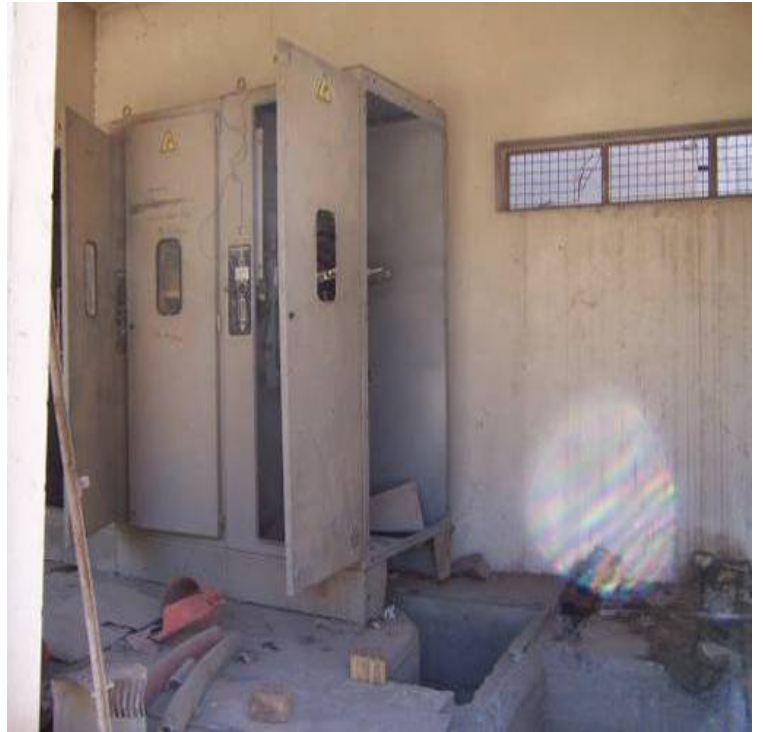
**Site Photo 4. Previously existing generator room
(Photo courtesy of the USACE)**

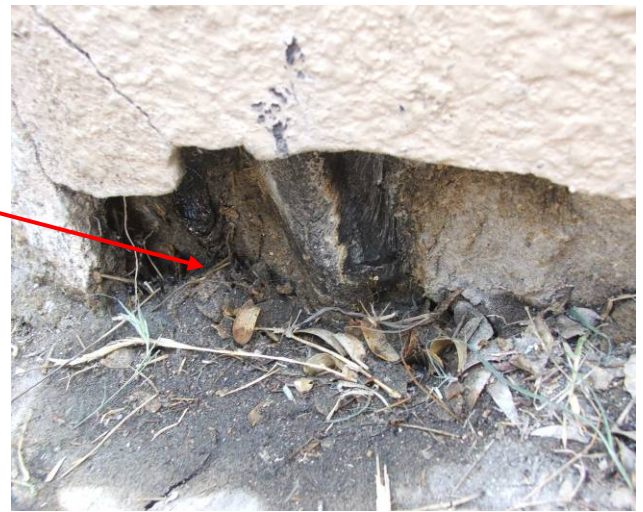
Site Photo 59. Enlarged view of expansion joint material
